Influence of rust on crashworthiness

Crash tests of rusty cars

Anders Ydenius
Anders Kullgren

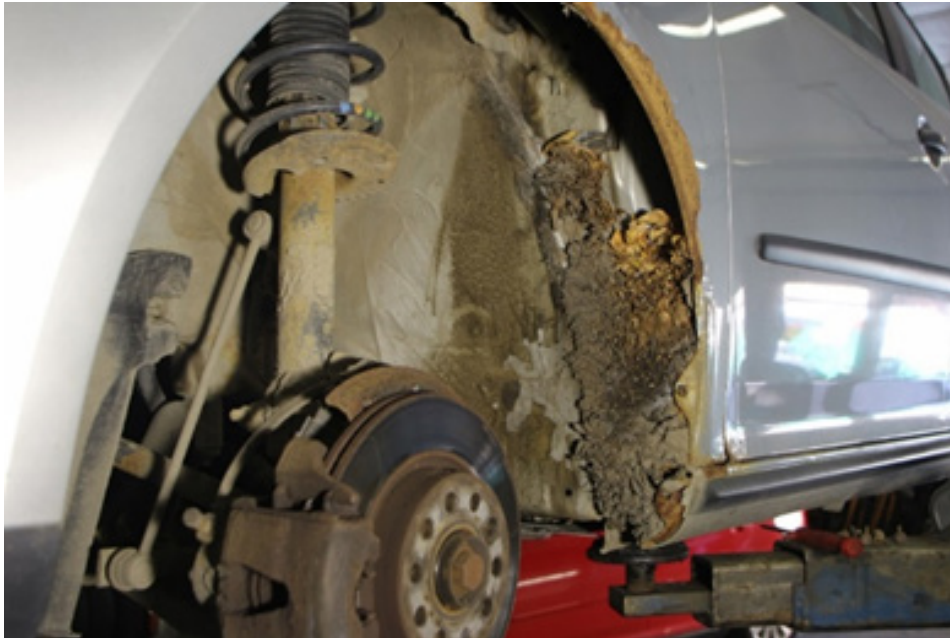
Traditionally, rust protection has consisted of various surface treatments of panels and beams together with the zinc plating of certain parts. Over the last decade, it has become increasingly common to use plastic or felt inner fenders to protect the wheelhouses from stones and dirt from the wheels. Plastic panels are also used underneath the car's bottom plate to protect the undercarriage, but also to provide aerodynamic benefits. The introduction of these measures has been criticised as the car industry is considered to have simultaneously reduced the traditional rust protection. The consequence may be that moist sand and dirt penetrate behind fenders and panels without the possibility of being dislodged (Figure 1). Packaged moist dirt is then in some cases situated directly against the undercarriage. In particular, inner fenders in the front wheelhouses gather dirt against the front edge of the side beams and accelerate corrosion alongside beams and wheelhouses. These areas cannot be cleaned without removing the inner fenders.

Figure 1. Dirt behind plastic inner fender.

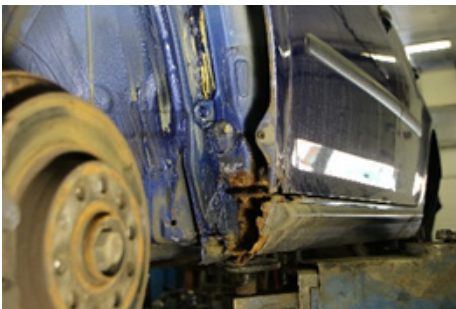
Car 1 had extensive rust damage along the side beam up to about 50 centimetres behind the front wheelhouse. The outer side of the side beam had extensive rust corrosion but it was located primarily on the outside of the side beam, which is why the inner sections were in relatively good condition. Figure 12 shows that the corrosion on the front end of the side beam was extensive but the corrosion was most extensive in the first decimetre. Figures 15-17 show the inside of the side beam at 2 and 3 decimetres respectively behind the wheelhouse.

Figure 12. Side beam - left wheelhouse front.

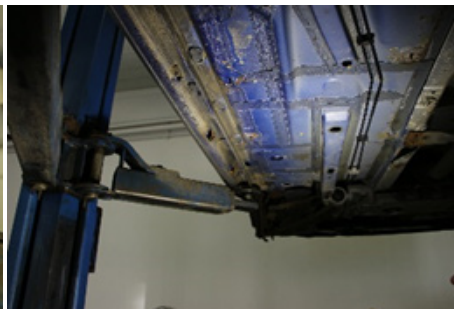
Figure 13. Bottom plate.

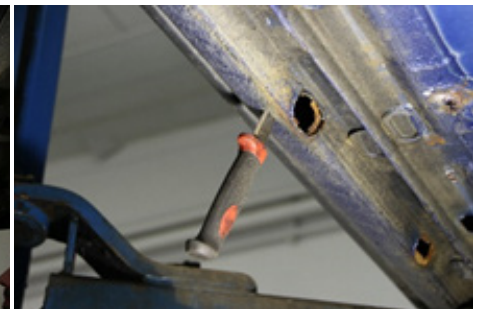
Figure 14. Left side beam.

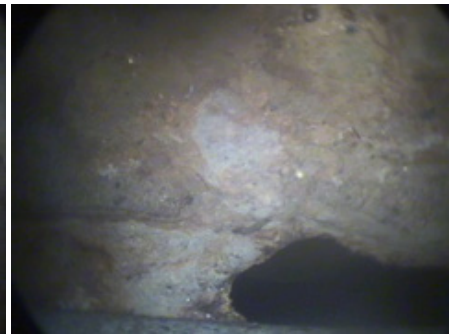
Figures 15-17 show the inside of the left side beam according to the camera view shown in Figure 11. Figure 17 shows a drainage opening and is not a rust hole. However, there is visible corrosion on the edges.

Figure 17. Camera view C.

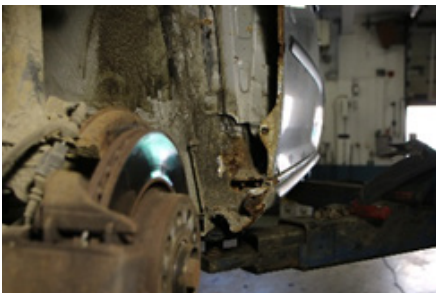
In the side impact test, the Golf had extensive rust damage in the front part of the side beam and was rusted through on the inside of the side beam around 3-5 decimetres behind the front wheelhouse. Less extensive rusting was visible on the bottom plate.

Figure 18. Side beam – left wheelhouse front.

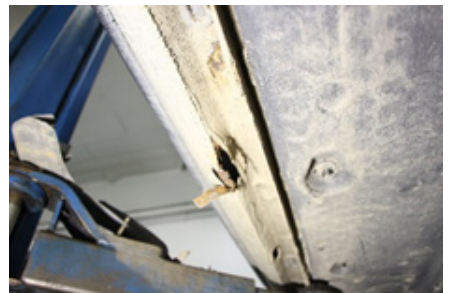
Figure 20. Left side beam..

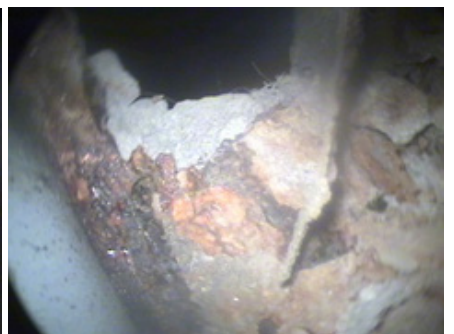
Figures 21-23 show the inside of the left side beam according to the camera view shown in Figure 11. Figure 23 shows a drainage opening and is not a rust hole. However, deep-seated rust is visible on the edges and surrounding surfaces.

Figure 23. Camera view C.

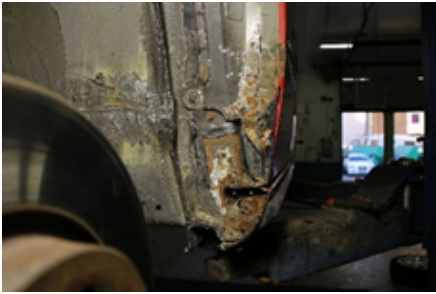
Car 3 was in the best condition but also had deep-seated rust in the front edge of the side beam. No rusting through further back along the side beam.

Figure 24. Side beam - left wheelhouse.

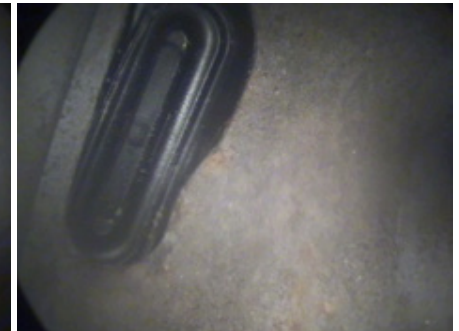
Figures 27-29 show the inside of the left side beam according to the camera view shown in Figure 11. Figure 29 shows a drainage opening in the side beam. Minor surface rust is visible around the drainage hole.

Figure 29. Camera view C.

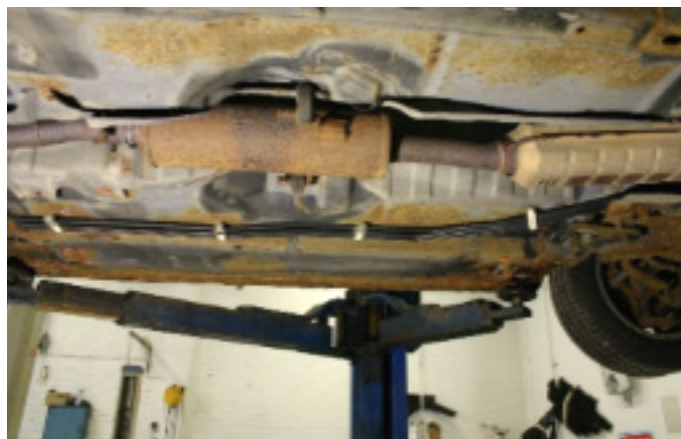
The longitudinal side beams are in an exposed position behind the front wheels and had widespread deep-seated rust where it was rusted through at certain points. The outer panel on the outside of the left side beam (Fig. 30/31) was rusted through to a greater extent but the inner part of the side beam was in a relatively good condition.

Figure 30. Left side beam inside.

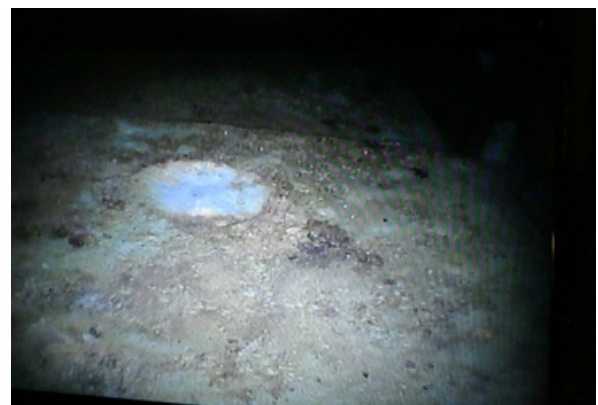
Figure 32 shows how the inside of the left inner side beam looked. The surface has extensive surface rust adjacent to deep-seated rust.

Figure 33. Left side beam inside.

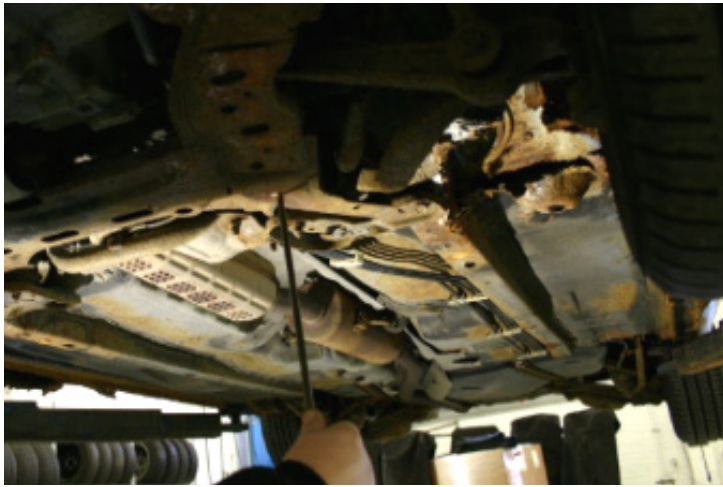
The front-wheel suspension frame belongs to the lower of the crash force transmission paths (Figure 3). The front-wheel suspension frame was severely corroded and was assessed as having large areas of deep-seated rust (Figure 34).

Figure 34. Camera entry point back part of left front-wheel suspension.

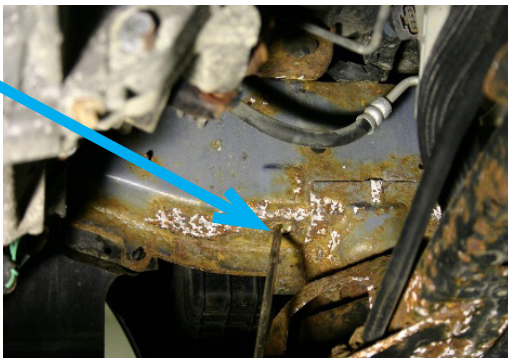
The lower part of the frame beam had sections of deep-seated (Figure 36) while other parts of the frame beam had lighter surface rust. The frame beam was assessed as having a rust level of 3.5 (Table 4).

Figure 36. Frame beam left front.

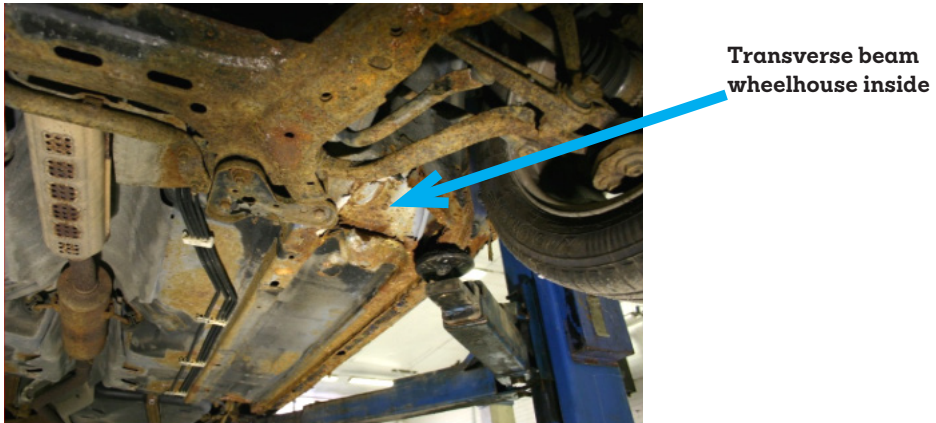
Left transverse beam's outer surface behind the front wheelhouse was completely rusted through and the inner section had widespread surface rust (Figure 38).

Figure 38. Left transverse beam behind front wheel.

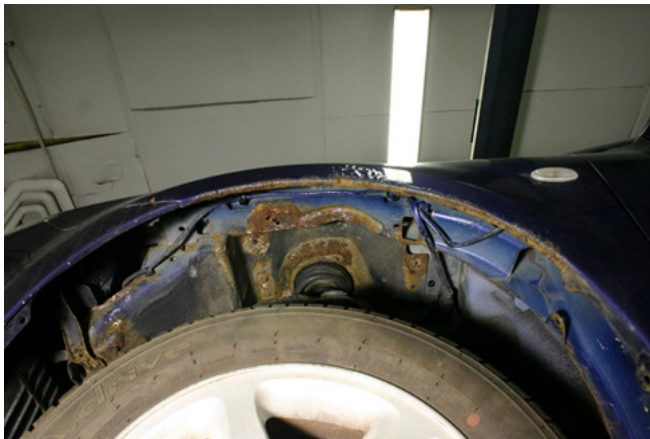
Upper wheelhouse beam is the upper crash force transmission path (Figure 3). Upper wheelhouse beam was rusted through at certain points (Figure 39).

Figure 39. Left wheelhouse beam.

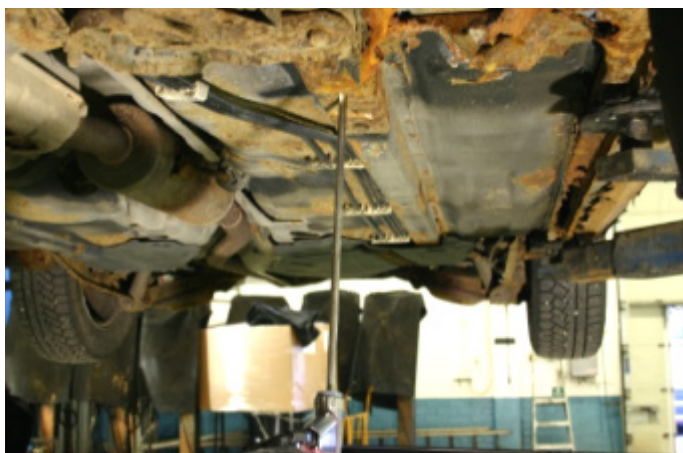
Figure 40 shows widespread surface rust but no deep-seated rust. The camera's position was in the front part of the inner side beam (Figure 40).

Figure 40. Camera entry point left inner side beam.

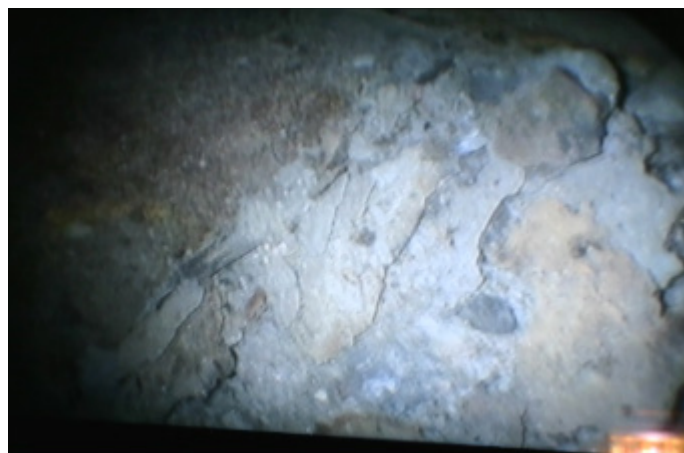
Framvagnsramen (Figur 42) hade något bättre roststatus i sidotestbilen än frontaltestbilen. För sidotestbilen bedömdes framvagnsramens rostangrepp vara en trea (Tabell 4) som innebar omfattande gravrost vilket syns i Figur 43.

Figure 43. Inside back part of left front-wheel suspension.

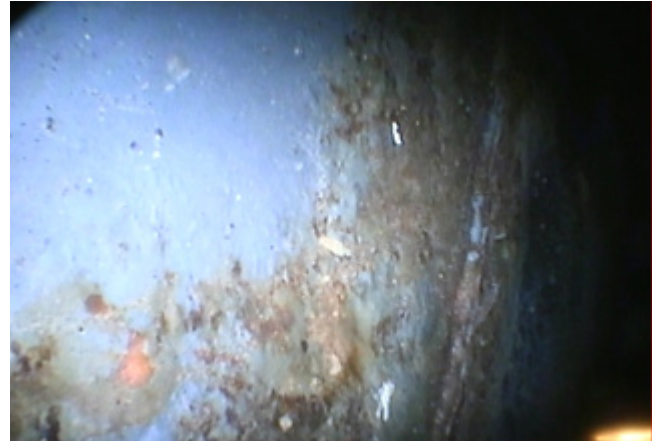
The lower frame beam (Figure 44) had sections adjacent to deep-seated rust (Figure 45) and was given a rust grade of three. The side test car's frame beam was however in better condition than the frontal test car and did not have as extensive a rust spread.

Figure 45. Frame beam left front inside.

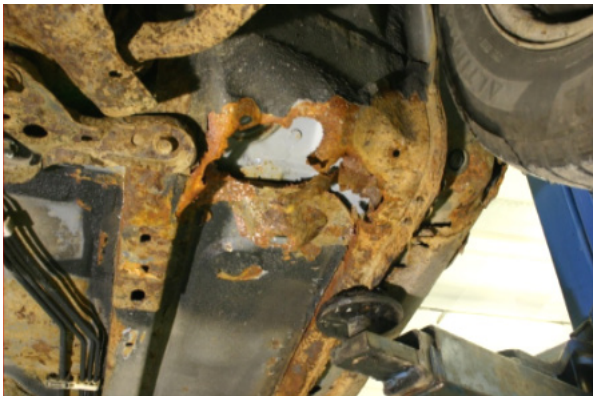
The left transverse beam's outside by the wheelhouse was completely rusted through and the inner section had some surface rust. The driver's foot space by the pedals can be seen behind the transverse beam. Both the test cars were given a rust level of five (Table 4) on the transverse beam behind the wheelhouse.

Figure 46. Left transverse beam behind front wheel.

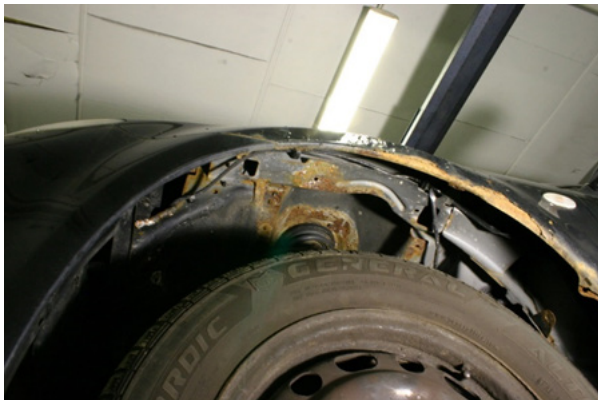
The left side of the wheelhouse beam has widespread surface rust and was rusted through at certain points (Figure 47). Both test cars had the same degree of rusting on the wheelhouse beam and were given a rust level of three (Table 4).

Figure 47. Left wheelhouse beam.

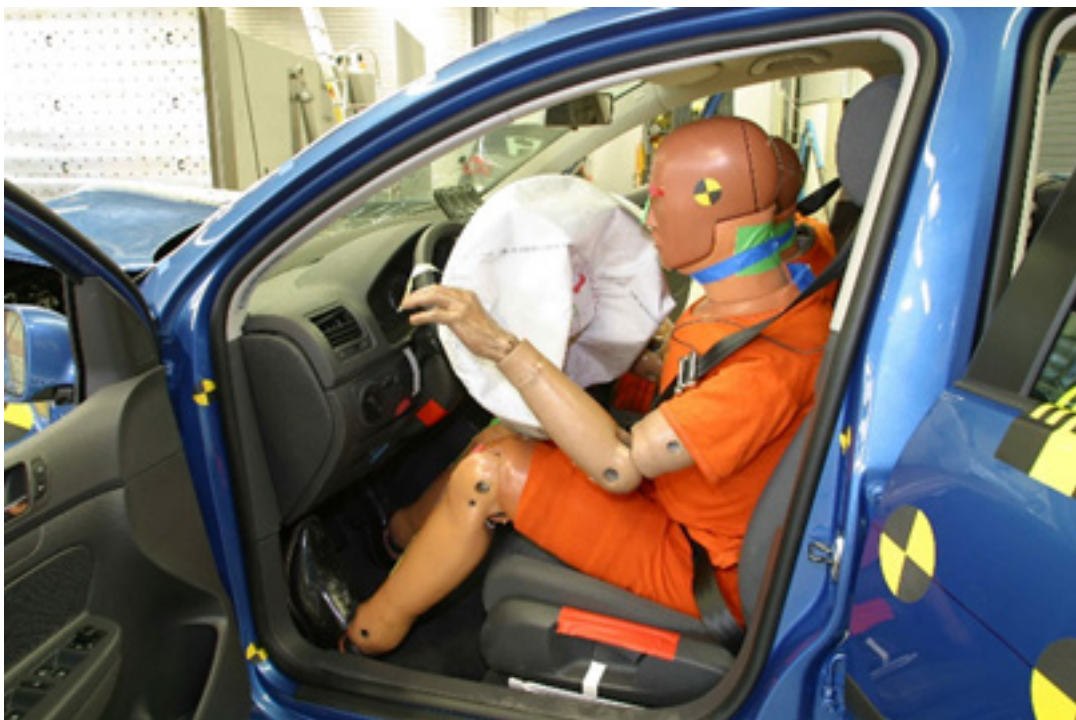
Figure 50 shows the foot space that passed without deformation. No movement of the dashboard or steering wheel could be detected. However, the dummy's right lower leg struck the dashboard, resulting in a point deduction.

Figure 50. Foot space

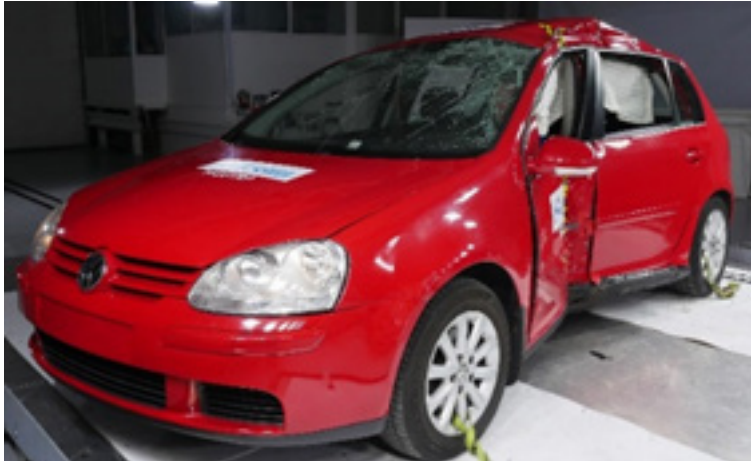
Figure 52 shows the deformation from the pole test. Table 7 shows that the data from the chest measurement was worse than the original test (Figure 4). However, this drop did not affect the final score. The 2004 protocol includes only data for the head in the pole test so the final score was a two, the same as the reference test in 2004. Individual measurements from the pole test are shown in Appendix 3.

Figure 52. VW Golf (rust) pole test.

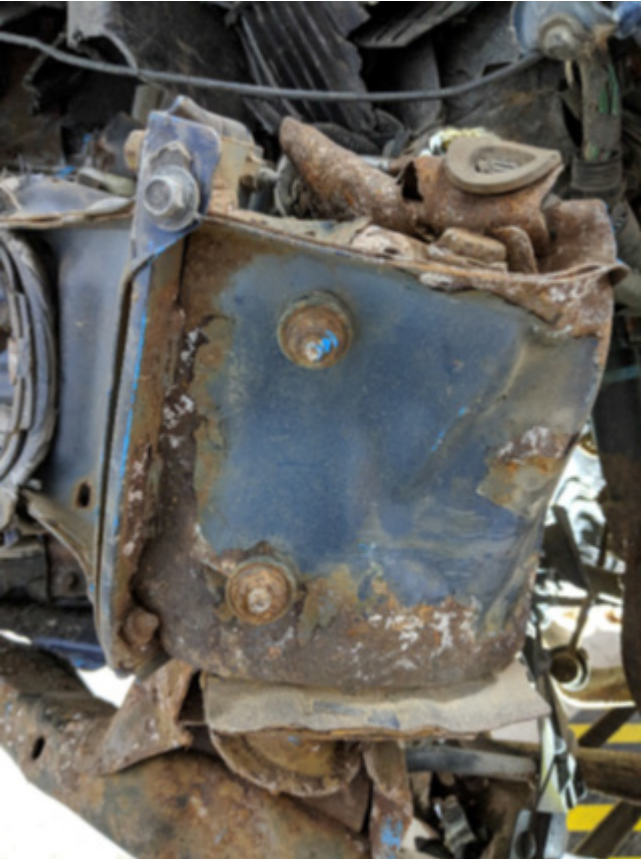
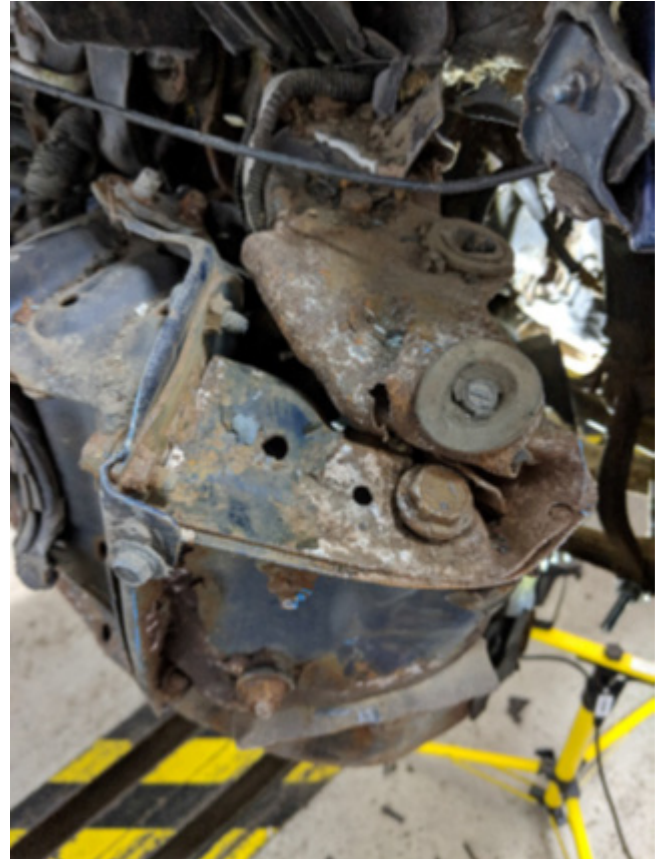
Figures 54-55 show the left frame beam which had extensive rust adjacent to deep-seated rust on the outside and joint. The underside of the frame beam (Figure 56) had deep-seated rust in the flanges indicating that the corrosion has spread significantly. Nonetheless, the inside of the frame beams looked better than the outside (Figure 37). Despite the rust corrosion, the frame beam has still been deformed in a way that suggests the rust has not changed the deformation properties of the frame beam.

Figure 54. Frame beam side view.

Figure 55. Frame beam from above.

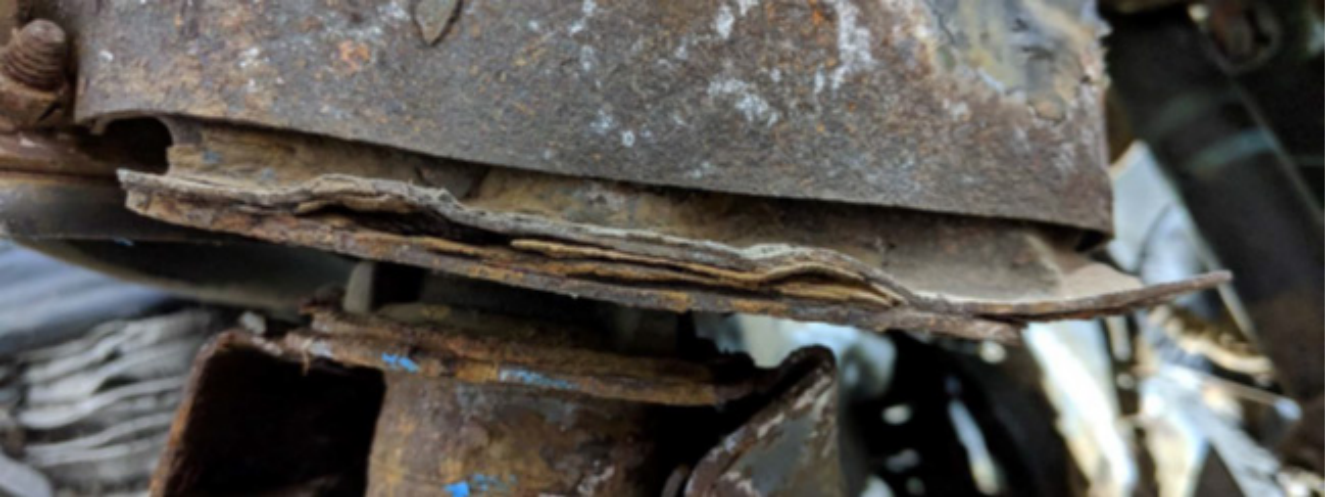
Figure 56. Frame beam underside

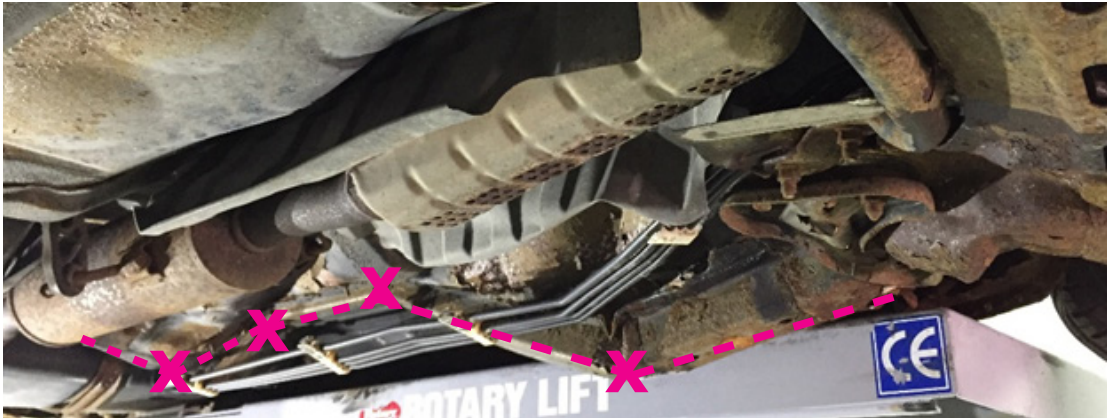
Figure 57 shows the inner side beam on the left side which had areas with widespread surface rust with some areas of localised deep-seated rust (rust level two). The inner side beam was deformed through it being bent in four different places (Figure 57) and pushing the floor upward. The inner side beam also separated from the floor (Figure 58). The transition between frame beam and inner side beam was heavily corroded by rust, which probably weakened that section. In turn, this contributed to a significant deformation of the driver's legroom. The type of deformation indicates that the inner side beam has reached the limit to be able to maintain its deformation properties for increased load. The consequence of the deformation of the inner side beam was that the floor on the driver's side and left passenger side deformed vertically about 15 centimetres with the consequence that the driver's seat mountings were moved. The deformation was greatest on the right-hand side of the driver's seat, which at the same time was violently tilted forward during the collision course. This impacted the forward motion of the dummy and contributed to the head of the crash test dummy bottoming out the airbag and twisting to the left.

Figure 57. Inner side beam

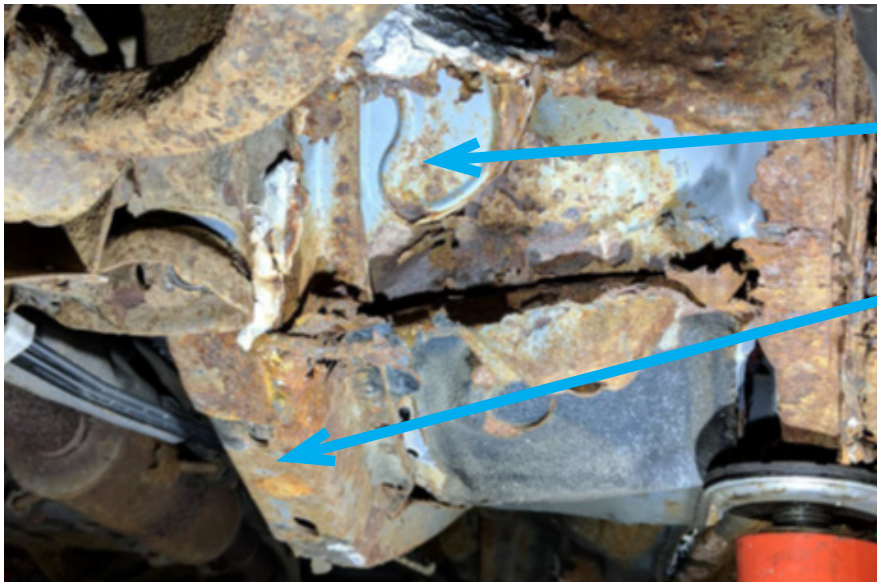
Figure 59 shows the transverse beam behind the front wheelhouse and the beginning of the inner side beam. The side beam has been deformed downwards, which the driver's foot space also has done. The deformation in the foot space has also become longitudinal as a consequence of the weakened transverse beam and the bend of the inner side beam downward and backward.

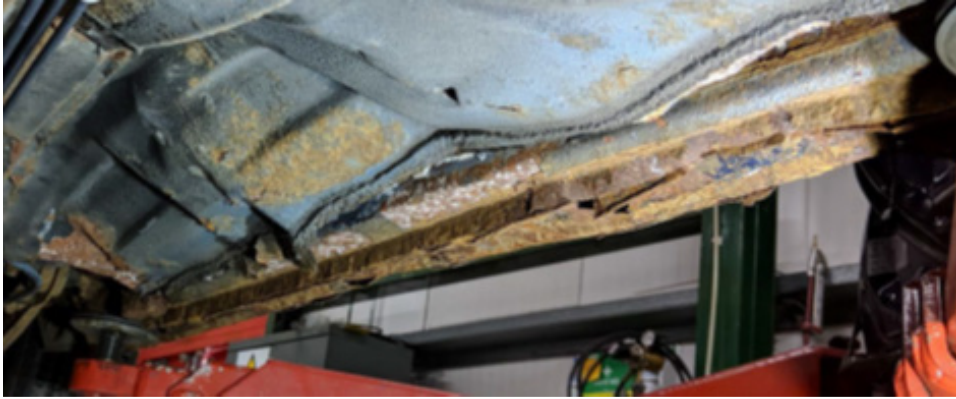
Figure 60 shows the left side beam whose rust level was set at three with extensive corrosion along the entire beam. Behind the front wheel, the side beam was rusted through in several places (Figure 60). The side beam is one of the structures that takes the most load in the frontal impact test, and a weakening here is most likely to result in increased deformation of the compartment. From measurements of crash scenarios, the side beam has been deformed about one decimetre more than the regular test, which corresponds to approximately 35 per cent greater longitudinal deformation of the threshold. The weakening of the side beam also caused a greater load on the inner side beam, which resulted in a greater deformation than in the original test.

Figure 60. Left side beam.

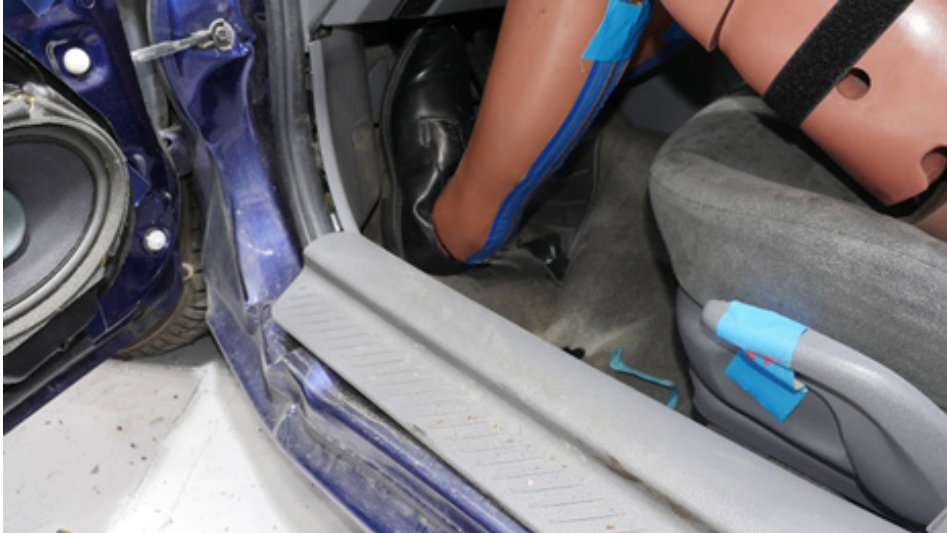
Figure 62 shows the deformation in the foot space. The deformation consisted of both longitudinal deformation of the pedal panel and the underlying surface and a vertical deformation of the floor. The floor deformation probably contributed to the points deductions given for increased contact forces on the lower leg and knee.

Figure 62. Foot space driver's seat.

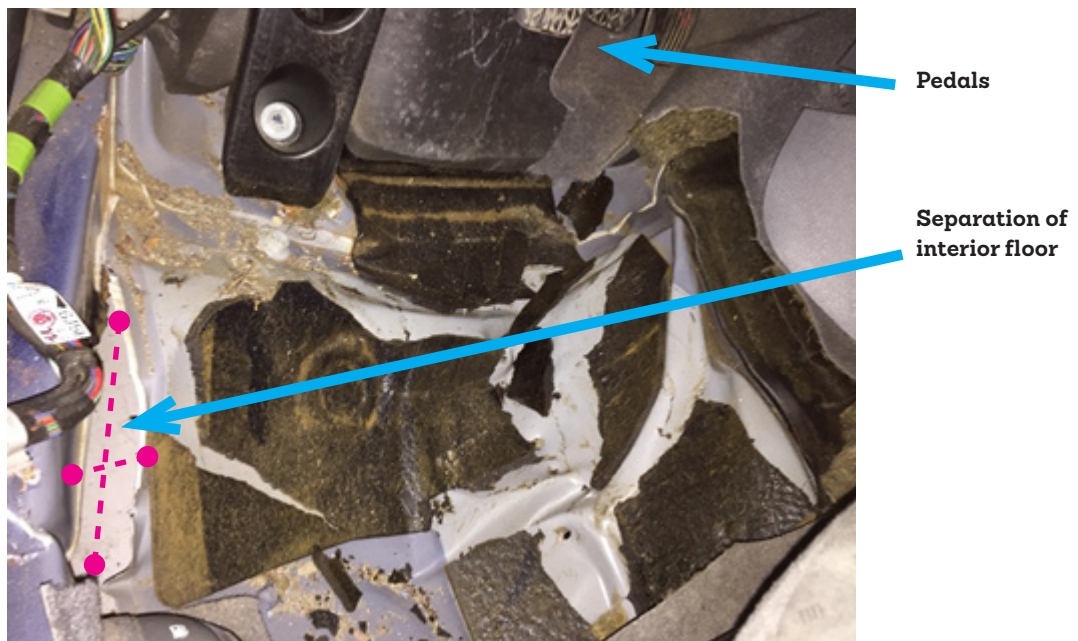
The deformation of the foot space also made the floor separate from the threshold, an indication that the section was overloaded (Figure 63).

Figure 63. Foot space driver's seat.

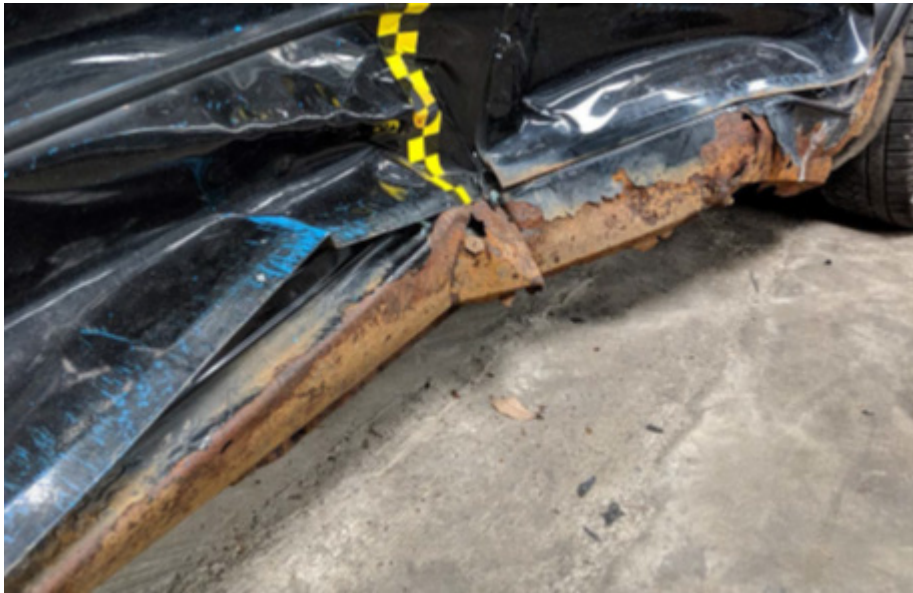
The side impact test resulted in greater compression of the dummy's chest, probably due to a greater deformation of the side beam (threshold) and floor compared to the original test. The deformation, in turn, caused extensive deformation and lateral movement of the driver's seat. Since deformation data from the original test is lacking, the cause of the increased compression of the dummy's chest cannot be attributed to greater deformation in the rust test. The side airbag has been hit and activated correctly, which cannot have contributed to the increased compression of the dummy's chest.

Figure 65. Side beam exterior

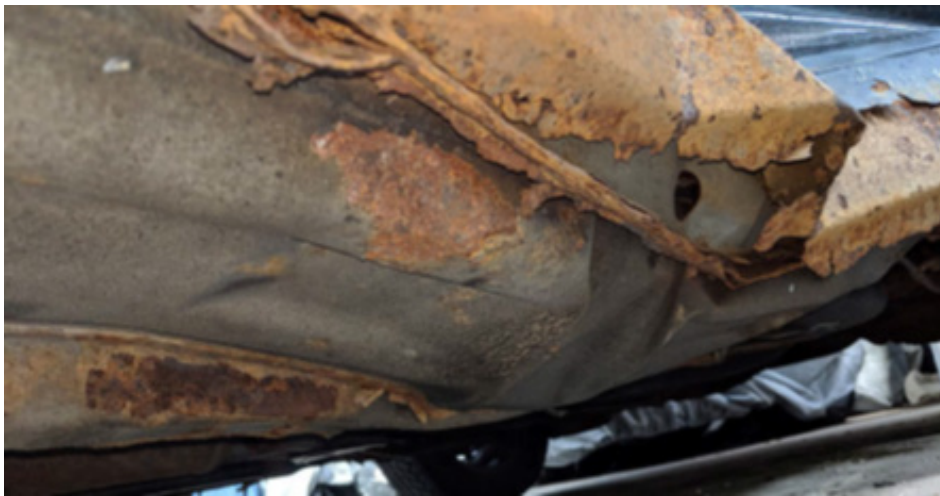
The close-up of the side beam's underside (Figure 66) shows that the deformation did not occur in a controlled manner, indicating being close to the fracture limit. The outer layer of the side beam has been spilt as a consequence of overload.

Figure 66. Side beam exterior askew from below.
