REMIBAR

*Evaluation of Migration Barriers
Remediated as part of Remibar*

EC LIFE+ programme
LIFE10 NAT/SE/045

Evaluation of migration barriers remediated as part of Remibar

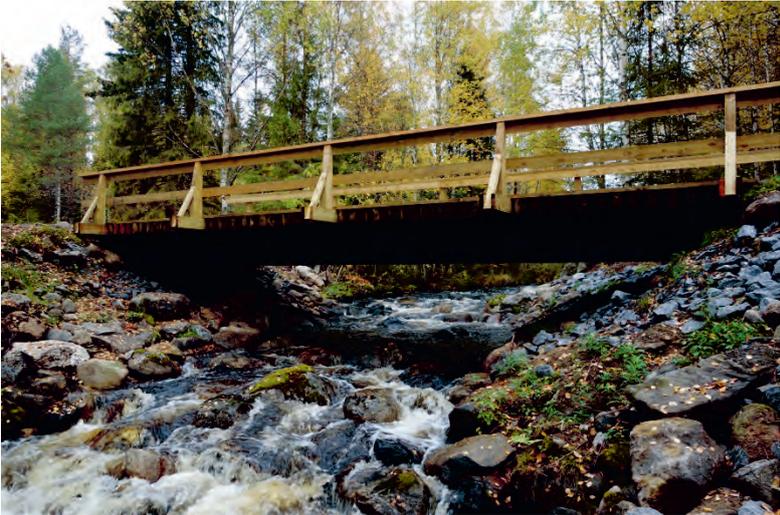
Figure 2. Object 244 in the Sävarån project area. Natural habitat under a bridge.
