LIFE Project Number  
**LIFE10 NAT/SE/045**

**FINAL Report**  
Covering the project activities from **01/09/2011 to 2016/12/31**

LIFE+ PROJECT NAME or Acronym  
**Remediation of migratory barriers in Nordic/fennoscandian  
watercourses - Remibar**

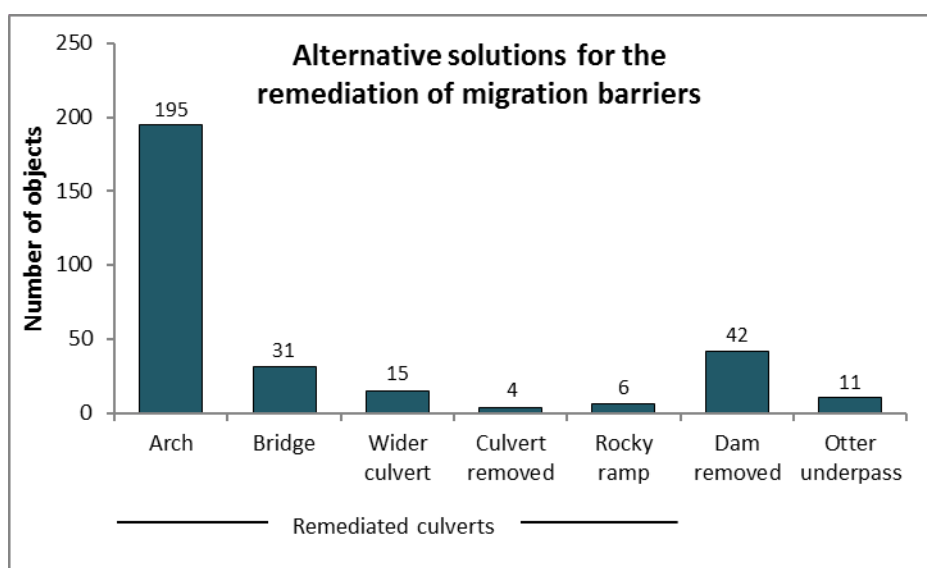
**Figure 6.** Number of objects replaced with different solutions.

The majority of the structures that constituted migration barriers for fish and other aquatic organisms consisted of culverts (251 objects) that were often too narrow and too steep, while 42 objects consisted of dams. Eleven migration barriers consisted of bridges that were lacking possibilities for otters to pass underneath the road safely. Most of culverts (77.7 % of the culverts) were replaced by arches, while 12.4 % were replaced by bridges, and 6.0 were replaced by wider culverts. A smaller proportion of the culverts were not replaced but remediated by constructing a rocky ramp downstream the culvert (2.4 %) or removed and not replaced with a new construction as the roads were no longer in use (1.6 %) (fig. 6). The 42 dams were removed, and the original or existing water level was maintained through the construction of a rocky ramp. The eleven objects that constituted migration barriers for otters and other medium-sized mammals were remediated so that those animal groups should be able to pass the road-river crossing without crossing the road.

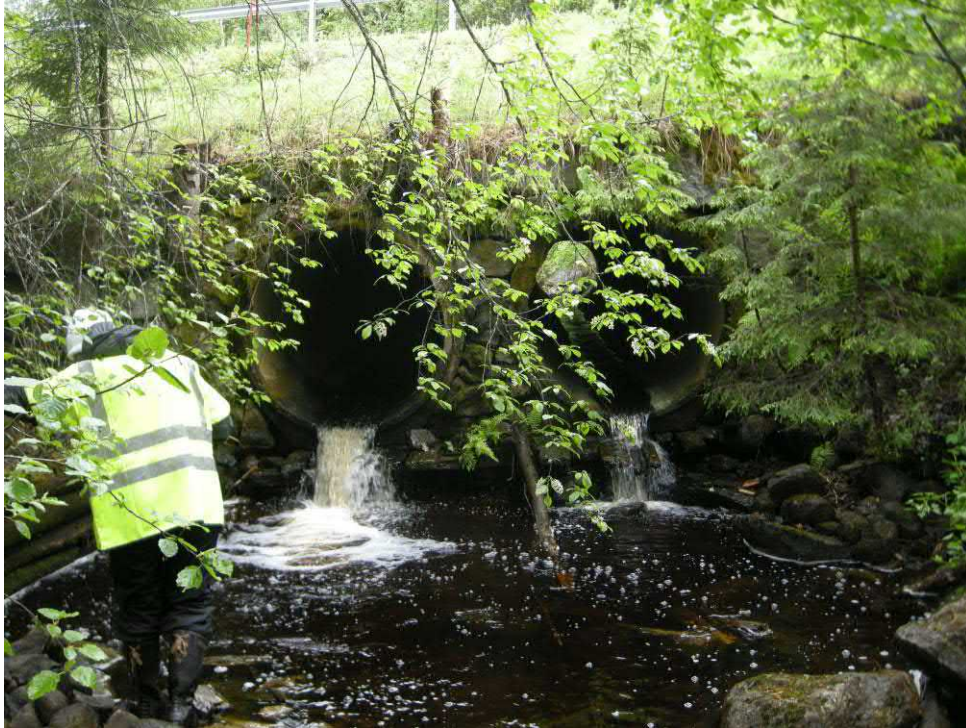
**Picture 1a.** Object 191 before, culverts with falls in the outlet.

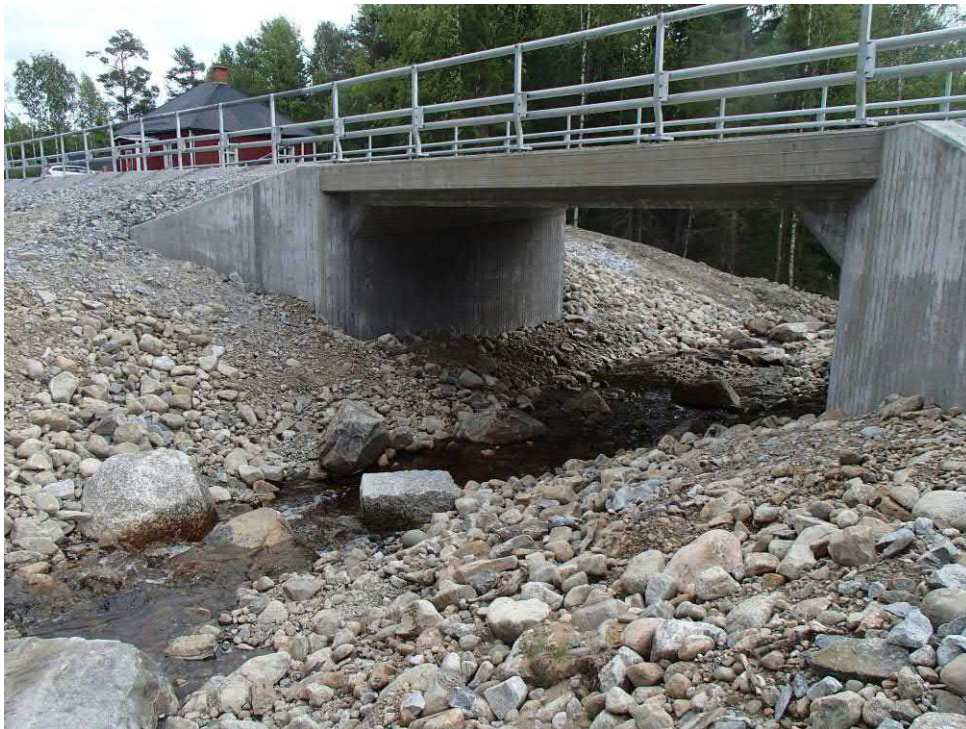
**Picture 1b.** Object 191 after, bridge with a natural riverbed.

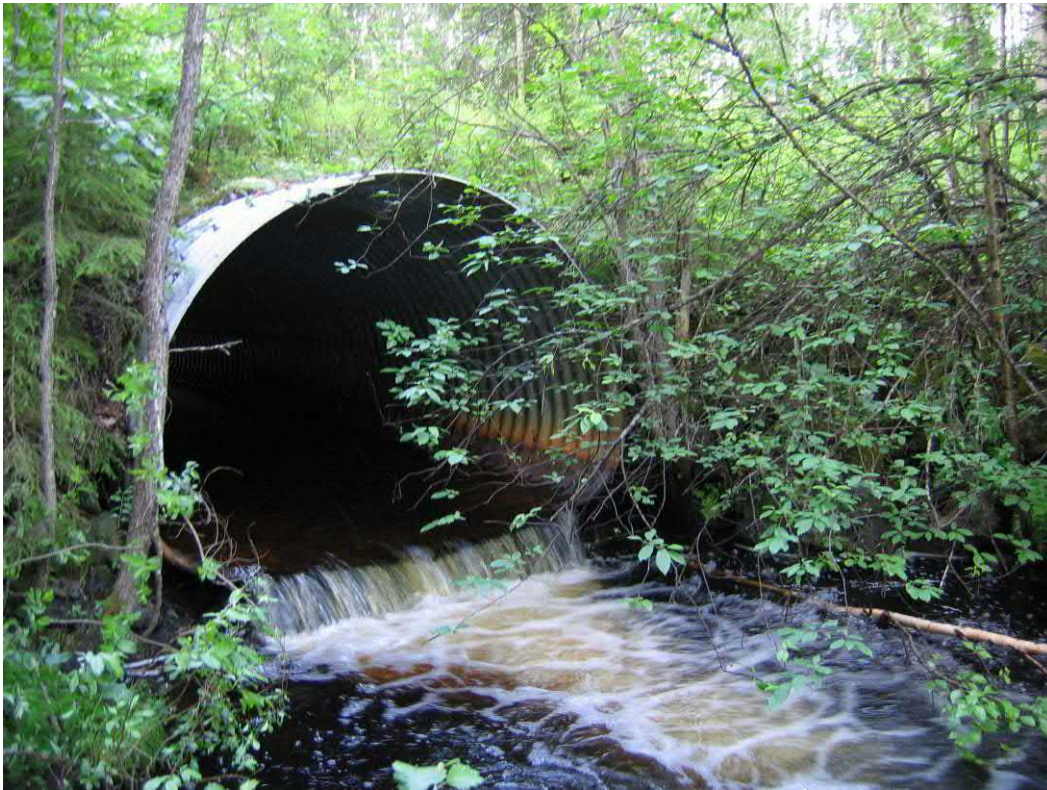
**Picture 2a.** Object 44 before, culvert with a fall at the outlet.

50 barriers are removed in total. All measures are listed in table 2. Map 2 shows the location of the restored objects and picture 2 shows an example on how it looks before and after the migration barrier is removed and replaced by a bridge.

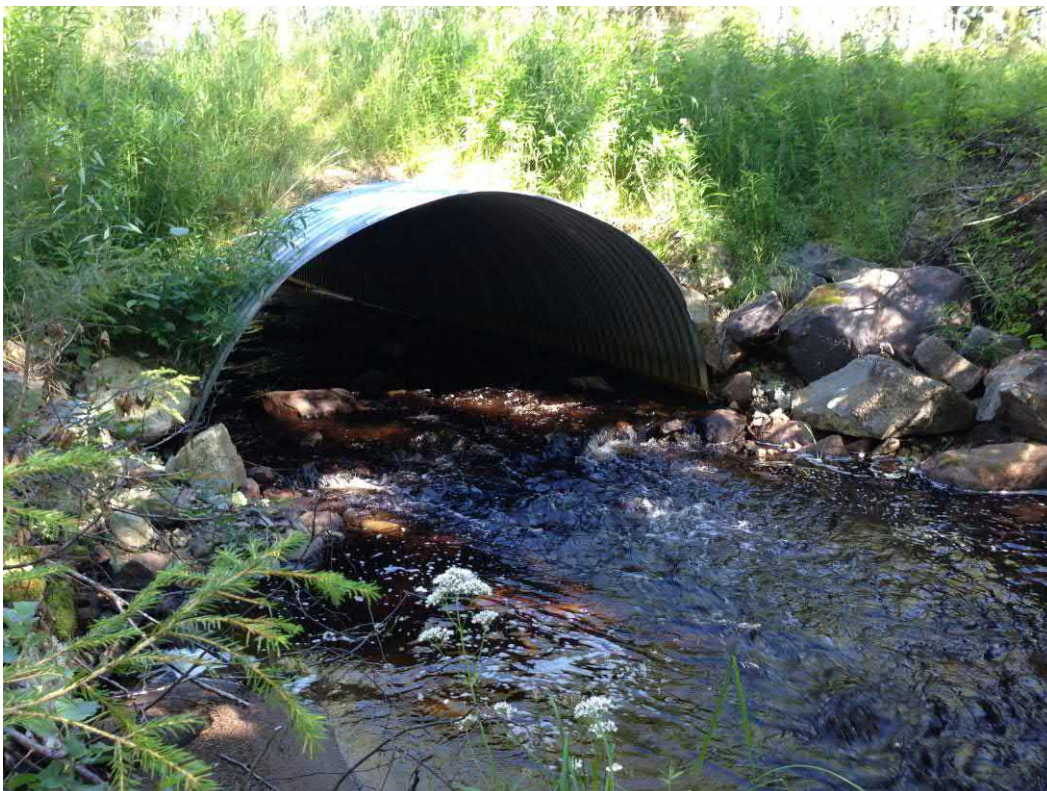
**Picture 2b.** Object 44 after, arch with natural riverbed.

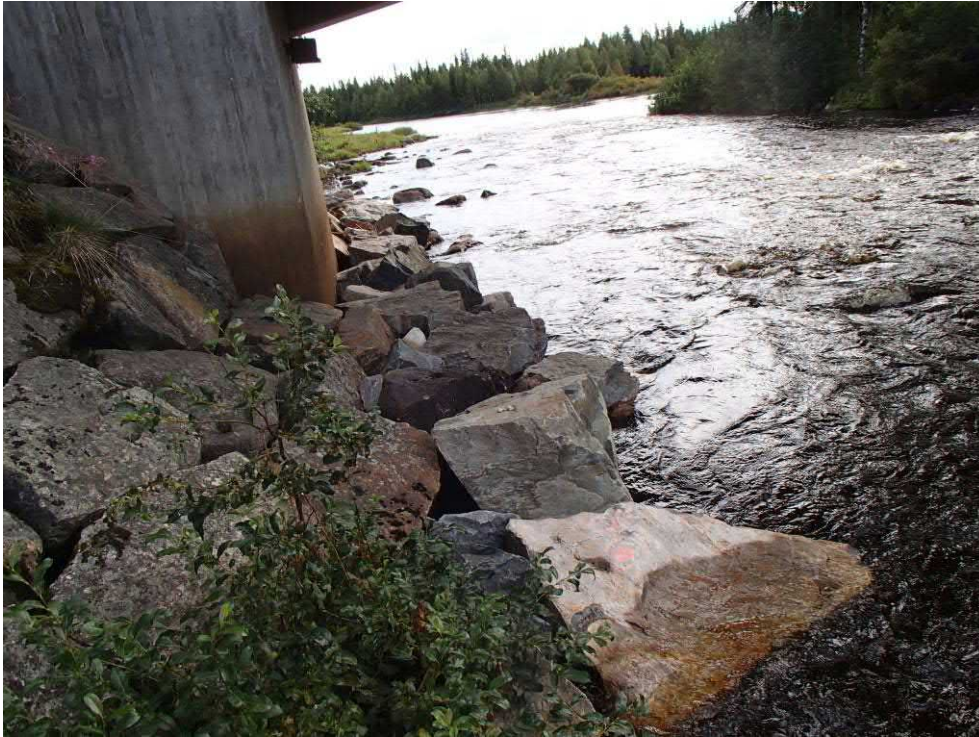
**Picture 3a.** Otter mitigation, object 24.

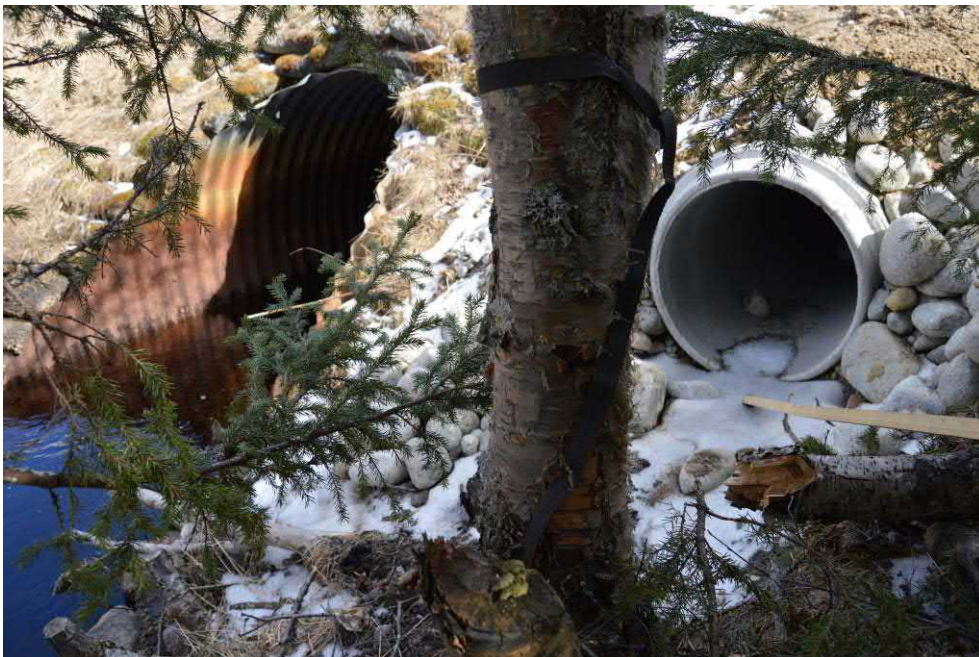
**Picture 3b.** Otter mitigation, a dry culvert for otters to go through, object 197.

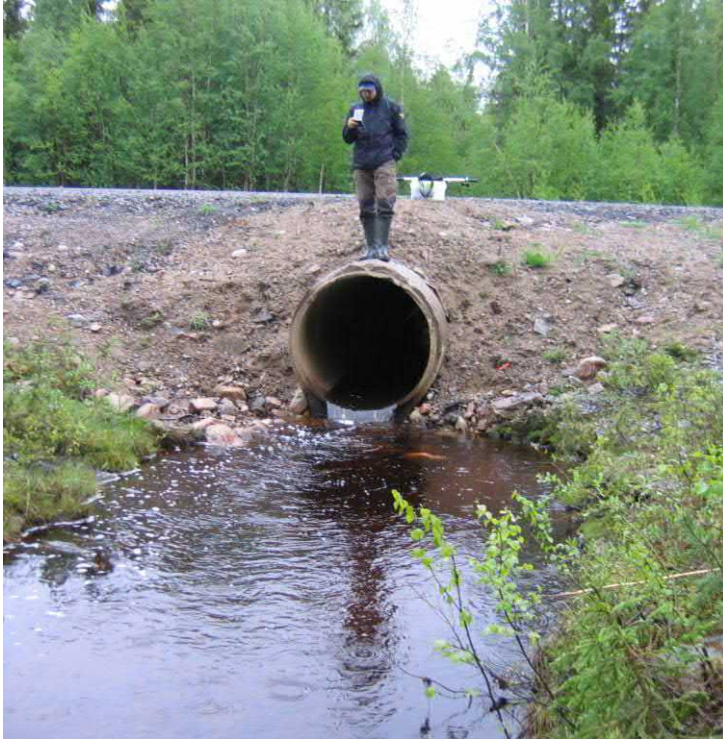
**Picture 4a.** Object 59, before, a culvert with a fall at the outlet

74 barriers are removed. All measures are listed in table 4a and 4b. Map 4 shows the location of the restored objects and picture 4 shows an example on how it looks before and after the migration barrier is removed and replaced by a culvert.

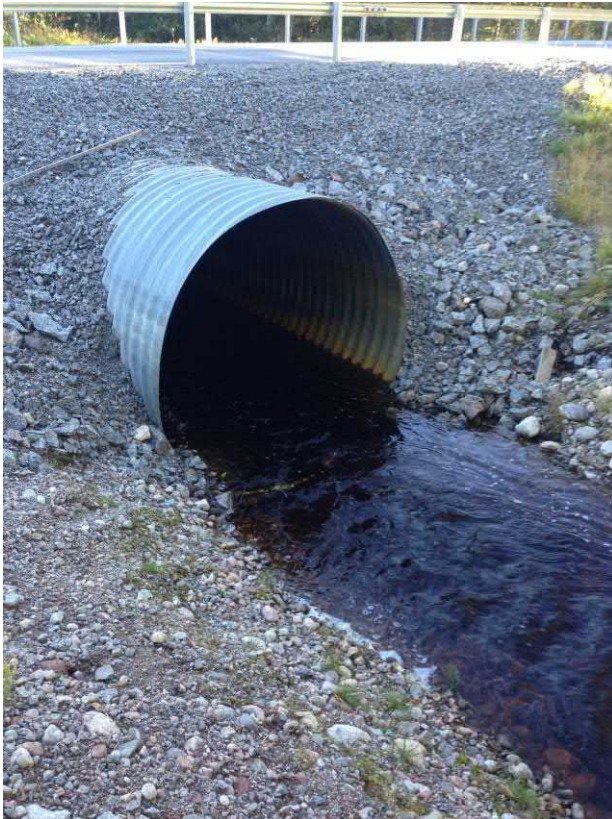
**Picture 4b.** Object 59, after, a culvert which is lowered and increased in dimension. Material is put in to the culvert to let the riverbed continue under the road

The main part of all migration barriers was replaced by an arch with a natural riverbed (see example in picture 2) but n° 181, 183, 184, 194 and 317 were replaced by culverts that were lowered and increased in dimension (see example in picture 4). Objects n° 138, 154, 158, 191 and 321 were replaced by bridges (see example in picture 1). N° 25, 196 and 197 are otter mitigations (see example in picture 3). In project area Lögdeälven 13 dams that were removed (see example in picture 5). N° 142 was removed since the road is no longer in use. At n° 188 a rocky ramp was built.

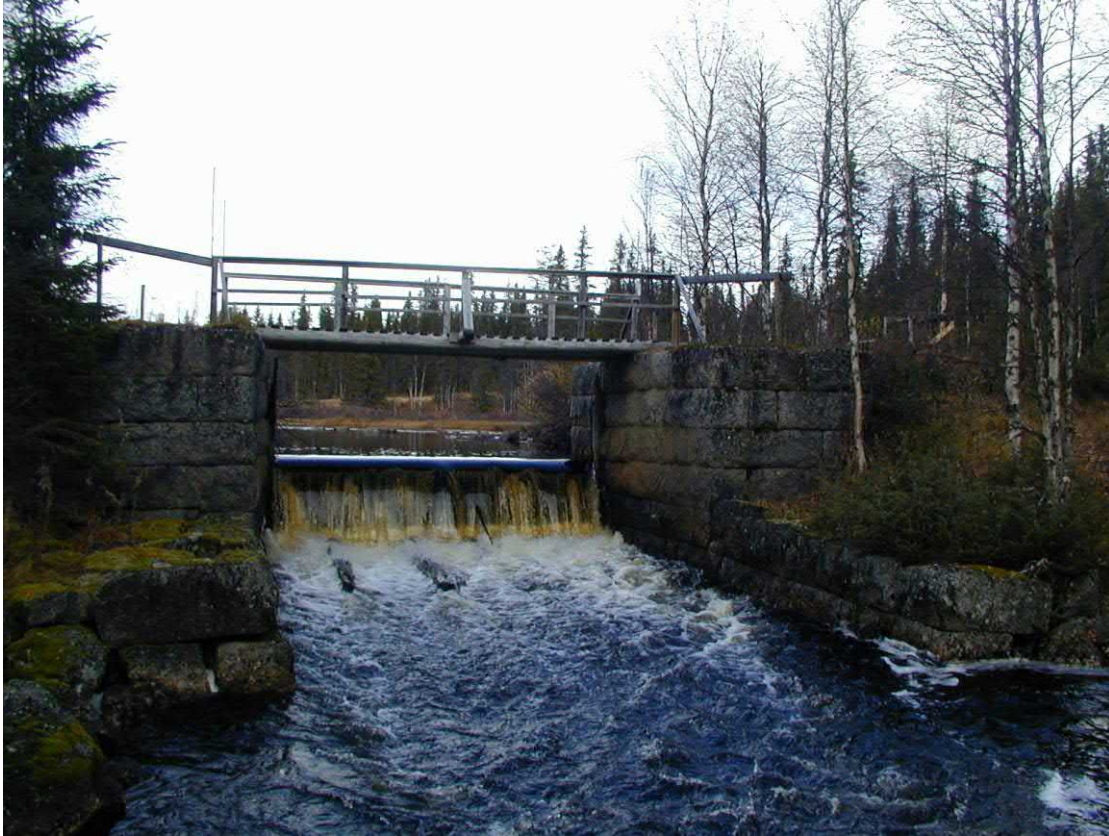
**Picture 5a.** Object 173, before, a dam that is a migratory barrier for fish

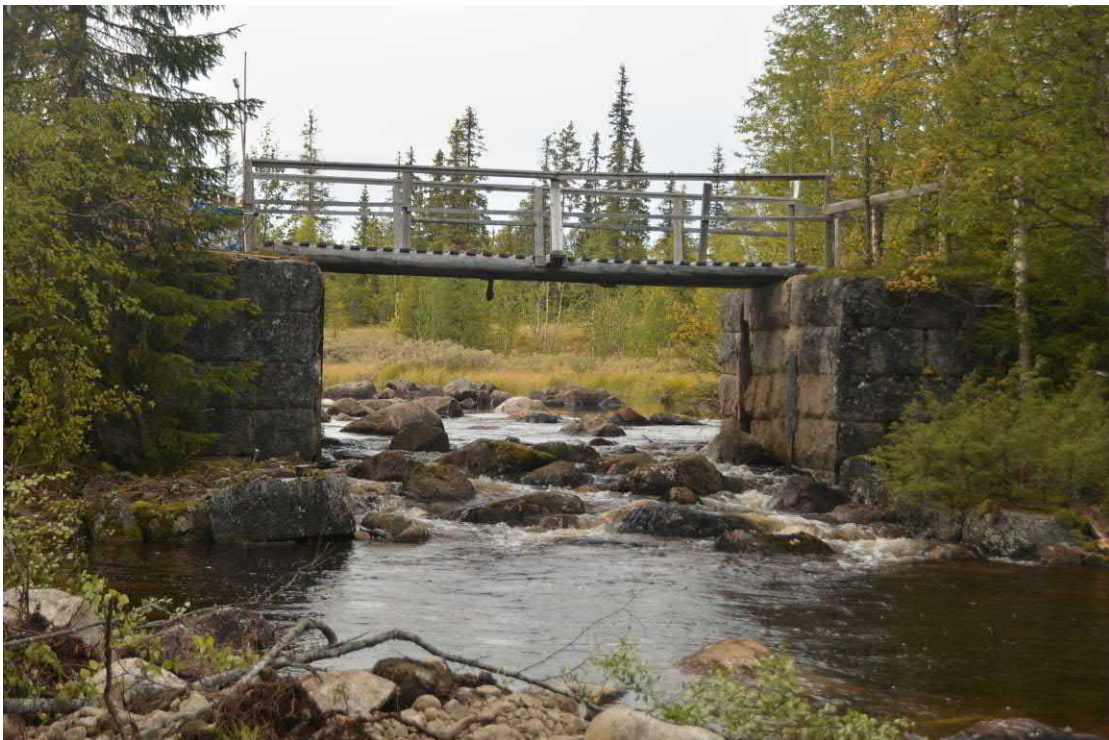
**Picture 5b.** Object 173, after, the dam is removed.

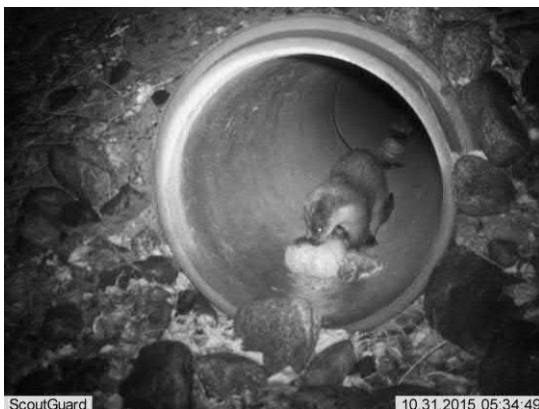
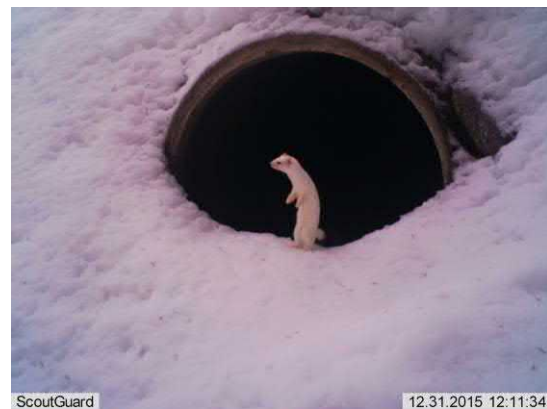
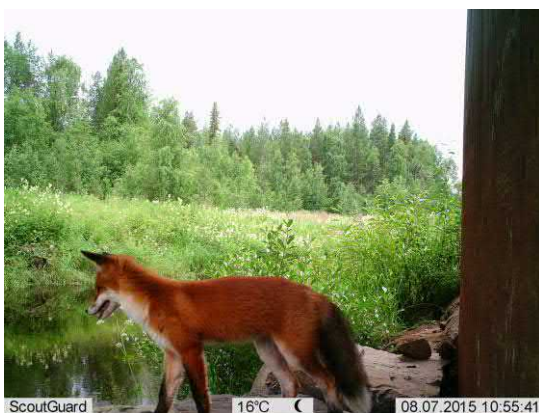
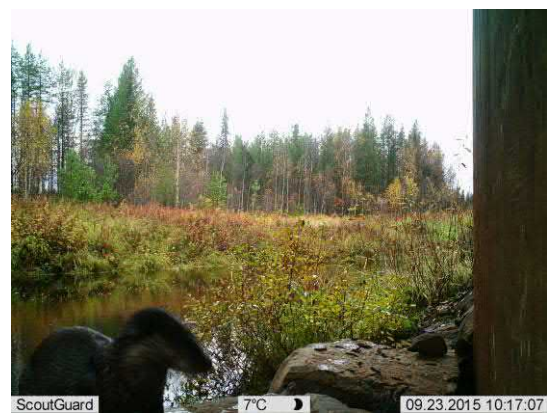
- Tracking has been done continuously at each object. The tracking has been done once every week for four week each season (four seasons). So in total each object has been visited 16 times every year.
- Cameras have been in place and the evaluation of the photographs is completed (picture 6).

**Picture 6.** Photographs taken with the surveillance cameras at the otter mitigations.
