REMIBAR

*Evaluation of mitigation measures
for otter in the Remibar project*

Author: Niklas Kemi and Torbjörn Nilsson, Trafikverket and Åsa Kestrup, The County Administrative Board of Norrbotten (Translation).

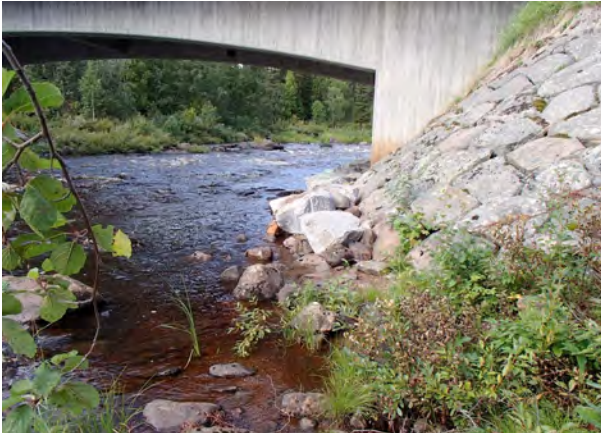
Figure 2. Dry bank made of boulders. Location Venetjoki River (ID 23).

A dry bank can be anything from an artificial dry bank made of natural materials to a moulded concrete edge. Ideally, appropriate material should be chosen so that the end result is a dry bank that is as natural as possible but at the same time durable so it does not get swept away at high flows. The underpass must have a minimum width of 50 cm. The dry bank must be high enough to be used at a range of flow regimes. The dry banks built as part of the Remibar project have been constructed using large boulders, see figure 2.

The construction of dry banks using big boulders has proven to be functional. The underpasses are being used by both small and medium-sized animals. The advantage of using larger boulders is that the risk of them being swept away during the spring flood is diminished, which may occur if material of smaller fractions is being used. It can be difficult to construct dry banks on a level that makes them functional at all flow regimes. This is the situation in Northern Sweden, where the water level varies greatly between floods and the mean water level. The constructed dry banks are covered by water for a short period of time during the snow melt and the spring flood. At three of the five sites with dry bank, otter has been documented with camera (the Råne, Skrövån and Venetjoki Rivers).

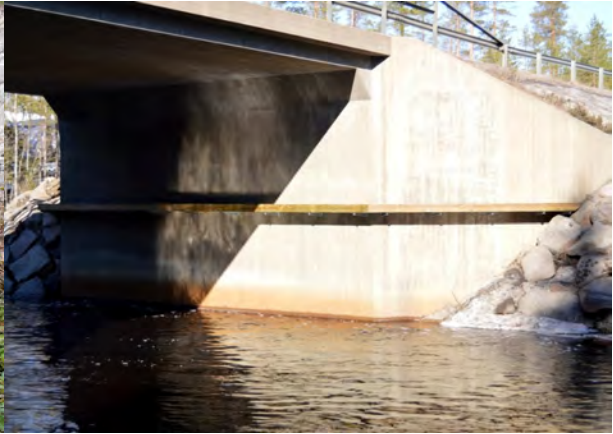
Figure 3. A constructed ledge at Kattån river (ID 107).

Ledges can be constructed under bridges as well as culverts and arches, see figure 3. The ledge should be a natural extension of the shore and be placed so it can be used at most flow regimes. The ledge must have a minimum width of 40 cm.

A ledge has been constructed at two sites. However, the results from the follow-up reveal that the ledge in the Kattån River has not been used by species other than squirrel and small rodents. The presence of otter

and other species of animals near the watercourse has been documented during animal tracking wintertime, but neither animal tracking nor camera surveillance indicate that they have been using the ledge. One reason could be the placement of the ledge. Its placement higher up makes it difficult to get a good connection with the shoreline. Ledges are placed higher up to avoid the influence from the break-up of ice and to protect them from being covered by water during high flows. The ledge in Vettasjoki is somewhat better connected to the shoreline and has been used by otter, mink, stoat and small rodents.

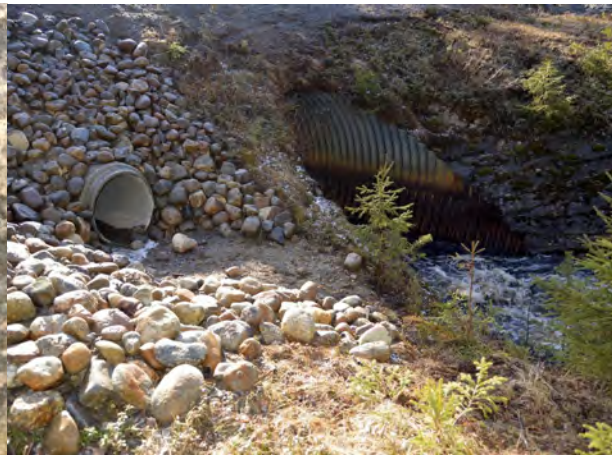
Figure 5. A dry culvert with complementary structures, Röjavattsbäcken Creek (ID 196).

Dry culverts are placed in close proximity to the bridge as close to the water as possible in order for the animals to find and use it. However, it must be placed above the high-water mark. A 600-mm wide culvert is preferred as it will also be used by other small and medium-sized animals. Some structures made of stone have been constructed to direct the animals towards the culvert, see figure 5.

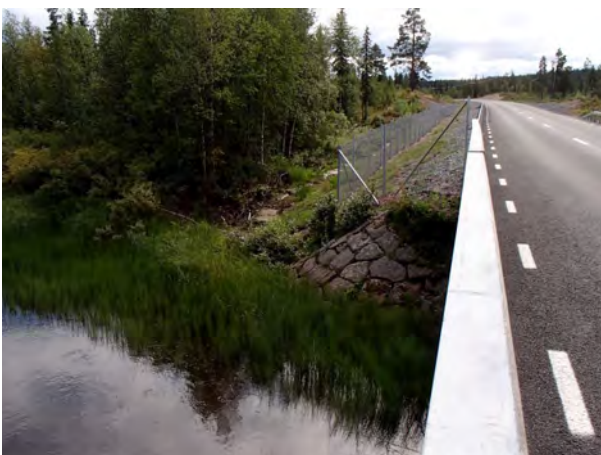
Figure 6. A fence in Nattajoki Creek (ID 22).

Fences can be used to direct otters and other medium-sized mammals towards an underpass, see figure 6.

Fencing as a remediation effort has been carried out in the Nattajoki River. At this site, fences have been put up on both sides of the bridge along a distance of 50 meters. Tracking of animals but no camera surveillance has been carried out at this site. Tracking of animals reveal that an otter on one occasion walked towards the fence. Thereafter, it was directed towards the bridge and crossed on the ice. Foxes have on some occasions walked around the fence and crossed the road. Fences can be effective for some species of animals but it probably depends on the design of the fence and the attractiveness of the underpass under the bridge. Problems associated with fencing include damage during snow removal, caused by the pressure of the snow being pushed to the side, and removal of vegetation around fences.

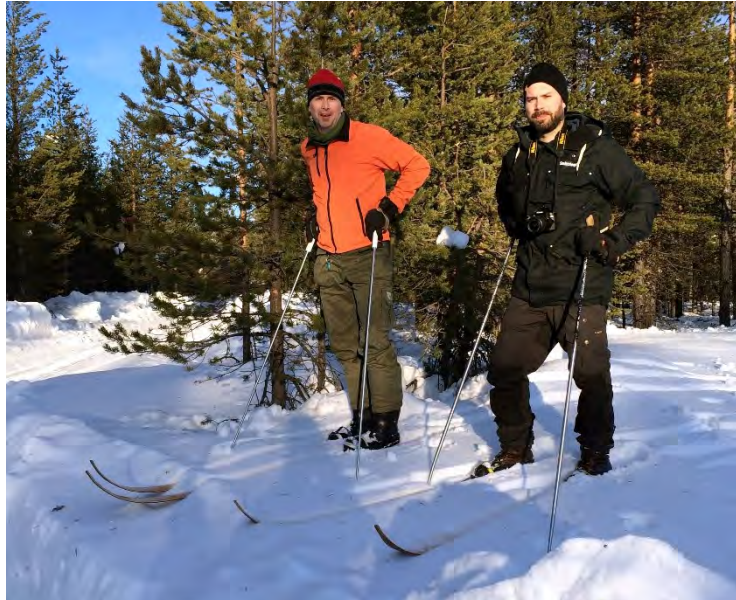
Figure 7. Snow tracking in harsh conditions requires the right equipment.

The animals were identified to species based on the tracks and scats. The results were recorded in a protocol. Some documentation was done using photos. Snow tracking requires the right equipment, including back country skis, see figure 7.

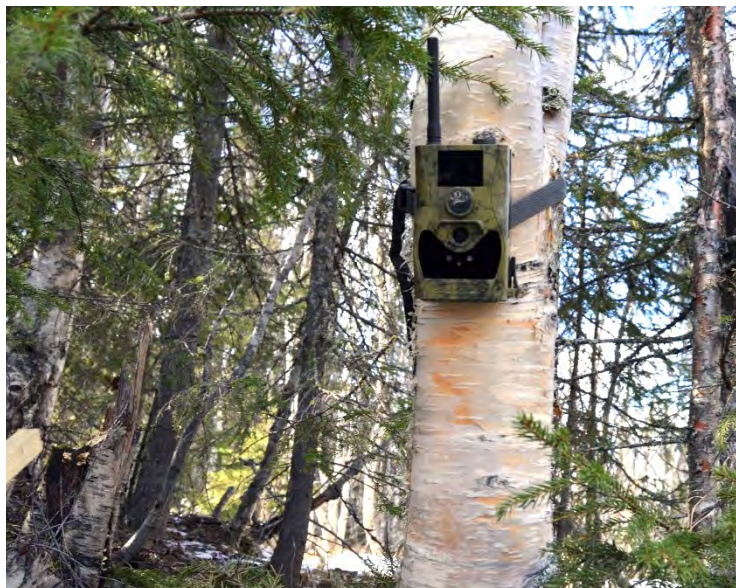
Figure 8. The underpasses were monitored with cameras.

The cameras being used are equipped with motion detection. They rapidly and automatically take three pictures when animals (or other objects) are moving. The cameras used at the monitoring were of the model ScoutGuard 880MK-8M (see figure 8).

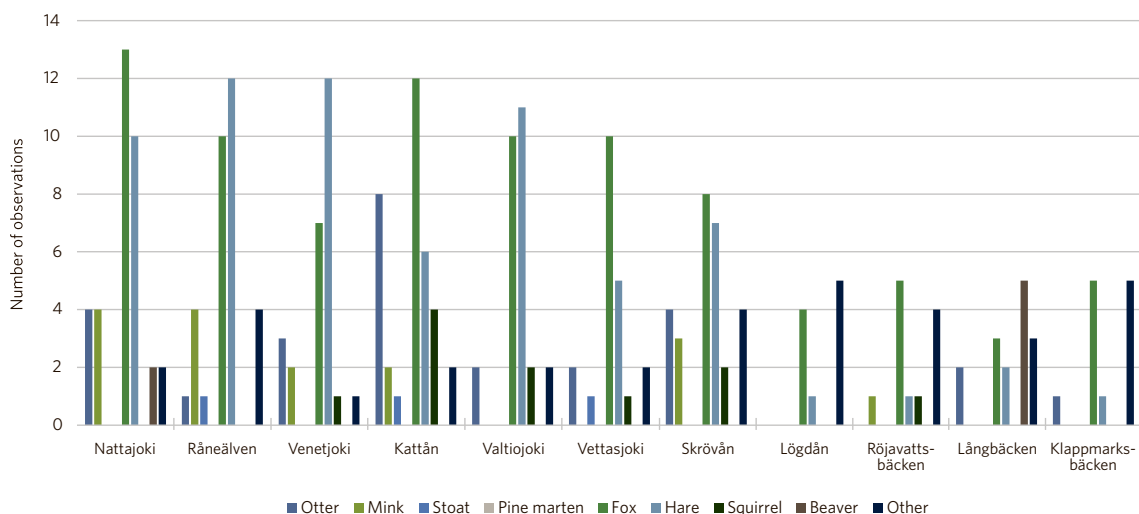
Figure 11. Number of observed tracks within a distance of 100 m from the constructed underpass per animal species and object. The number of sampling days varies from 14 to 18 per object.

The results from the follow-up reveal that different species of animals frequently use the majority of the constructed underpasses. A higher number of animals have been recorded using camera monitoring during the bare ground season compared to animal tracking in snow, see figures 9-14. It can be due to the fact that camera monitoring was carried out during a higher number of days. In addition, the movement patterns of many animal species differ between the summer/bare ground and winter seasons. For example, the otter depends on open water to catch fish, which limits the area where it resides.

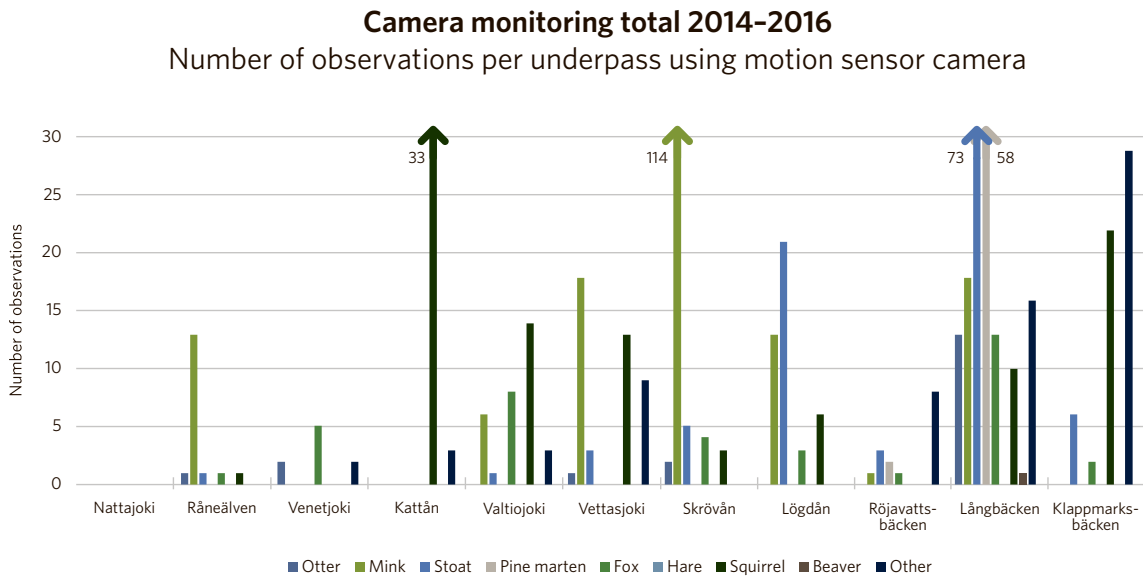
Figure 13. Number of species recorded with motion sensor camera and number of observations per site.

The results from the camera monitoring reveal that the dry culvert in the Långbäcken Creek is the underpass that has been used on the highest number of occasions by the highest number of species, see figures 13-14. Otter has been photographed at the underpass on eleven occasions. On the contrary, the dry culvert near the Klappmarksbäcken Creek has been used by only a few wild animals. Mostly cats have been photographed at this site. In wintertime, otter tracks have been confirmed on the ice. It is difficult to assess why there is such a big difference between these two dry culverts regarding the presence of animals. However, factors that may be important to consider are their placement relative to the watercourse and the shoreline, the general presence of animals in the area, and the proximity to settlements (presence of cats).

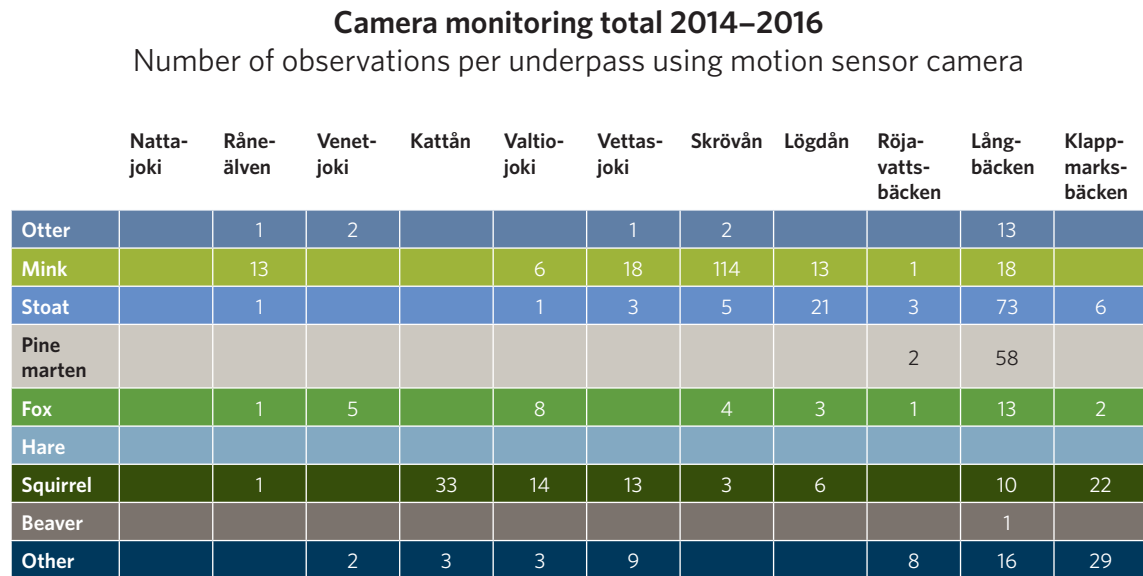
Figure 14. Number of species recorded with motion sensor camera and number of observations per site.
