VISION ZERO ACADEMY

Evidence based approach - the need of data

Kenneth Svensson Special adviser traffic safety Swedish Transport Administration

In-depth studies of fatal accidents

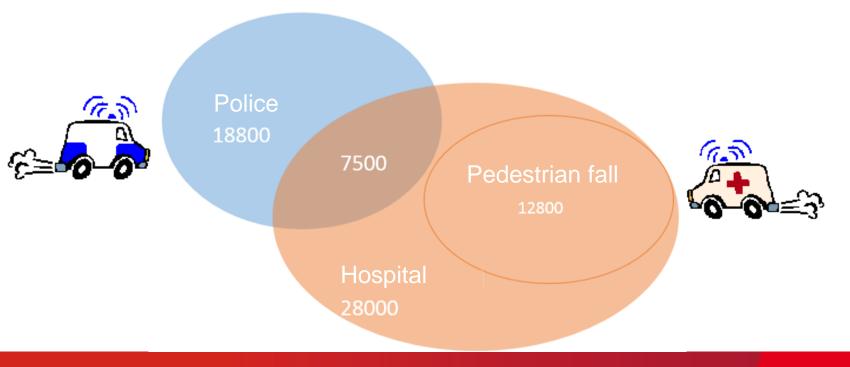
Coverage, from Police and Hospital

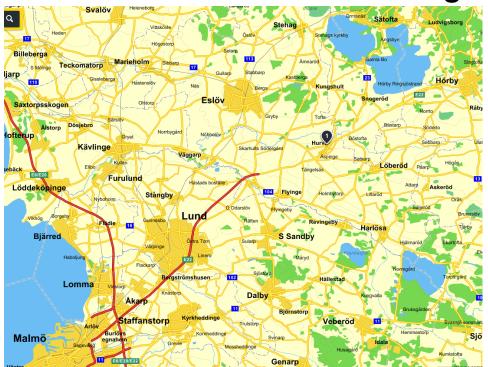
Pedestrian accident at a highway bus stop

- Highway bus stops opposite each other without any arrangement to prevent pedestrian crossing.
- No design requirements or guidelines regarding highway bus stops and the risk for pedestrian crossing.
- Deficiencies detected at several bus stops in Sweden.

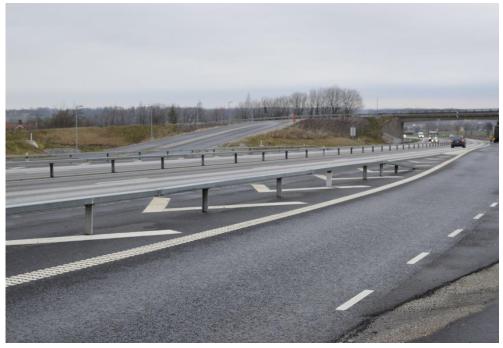
Bild tagen från norrgående busshållplats mot södergående hållplats

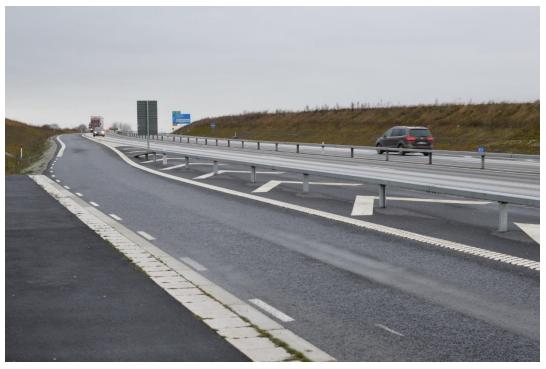
Vy norrut

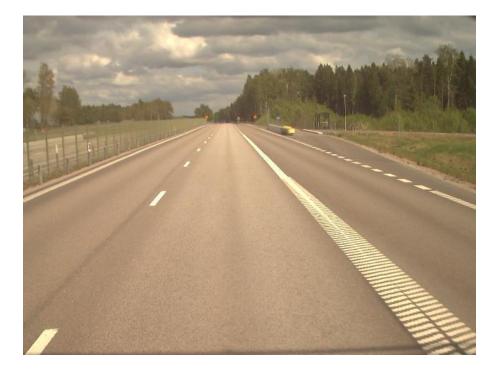
An example of a measure to prevent pedestrian

crossing.

- Address locations with high risk of pedestrian crossing with appropriate action present year. Responsibility: Regional Directors.
- Address locations with medium risk of pedestrian crossing with appropriate action within the ordinary planning process for next year. Responsibility: Regional Directors.
- Write design guidelines regarding highway bus stops and include them in the new version of the publication Road and street design guideline.
 Responsibility: Planning department.

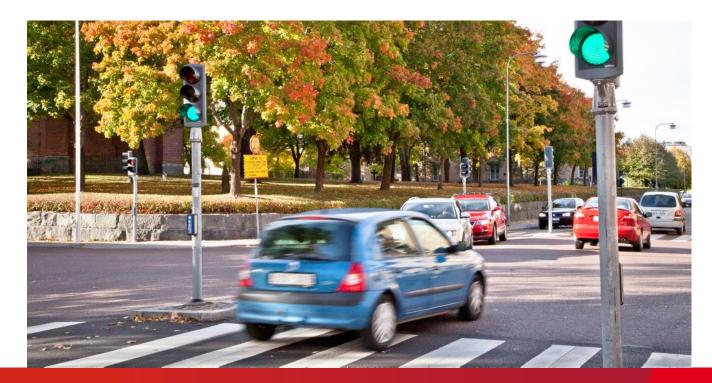
Stop line at pedestrian crossings
