Influence of rust on crashworthiness

Crash tests of rusty cars

Anders Ydenius
Anders Kullgren

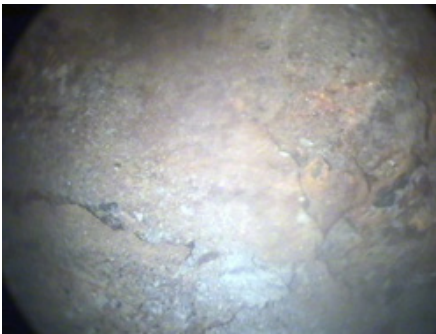
Figure 15. Camera view A.

Figures 15-17 show the inside of the left side beam according to the camera view shown in Figure 11. Figure 17 shows a drainage opening and is not a rust hole. However, there is visible corrosion on the edges.

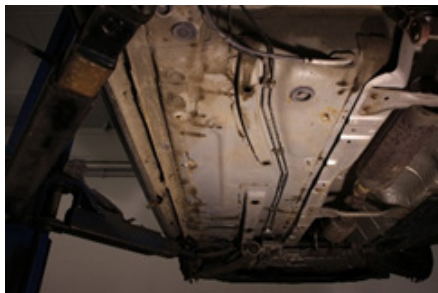
Figure 19. Bottom plate.

In the side impact test, the Golf had extensive rust damage in the front part of the side beam and was rusted through on the inside of the side beam around 3-5 decimetres behind the front wheelhouse. Less extensive rusting was visible on the bottom plate.

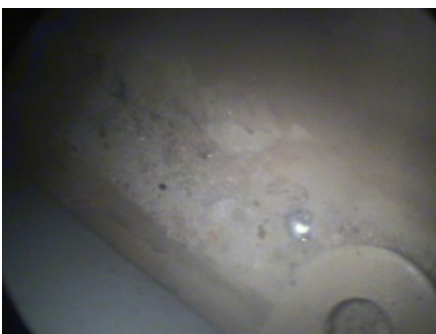
Figure 21. Camera view A.

Figures 21-23 show the inside of the left side beam according to the camera view shown in Figure 11. Figure 23 shows a drainage opening and is not a rust hole. However, deep-seated rust is visible on the edges and surrounding surfaces.

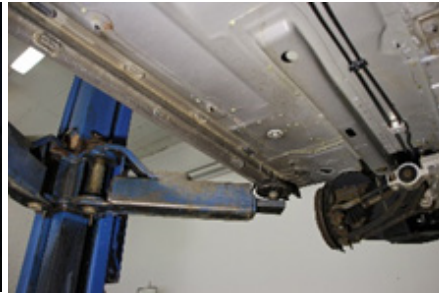
Figure 25. Bottom plate.

Car 3 was in the best condition but also had deep-seated rust in the front edge of the side beam. No rusting through further back along the side beam.

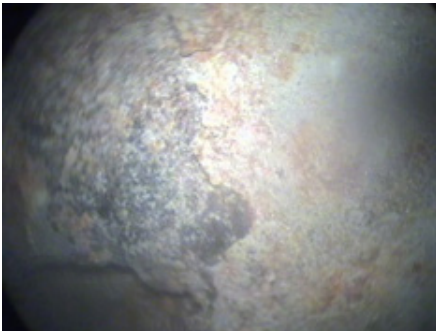
Figure 27. Camera view A.

Figures 27-29 show the inside of the left side beam according to the camera view shown in Figure 11. Figure 29 shows a drainage opening in the side beam. Minor surface rust is visible around the drainage hole.

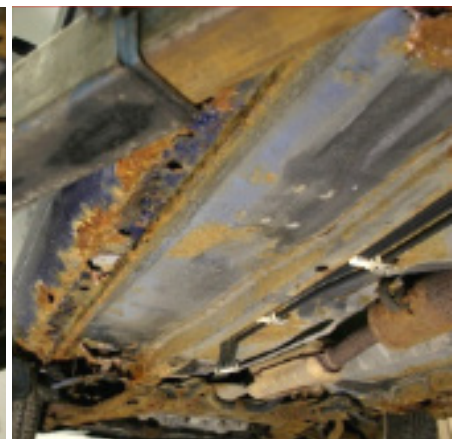
The longitudinal side beams are in an exposed position behind the front wheels and had widespread deep-seated rust where it was rusted through at certain points. The outer panel on the outside of the left side beam (Fig. 30/31) was rusted through to a greater extent but the inner part of the side beam was in a relatively good condition.

Figure 31. Left side beam outside.

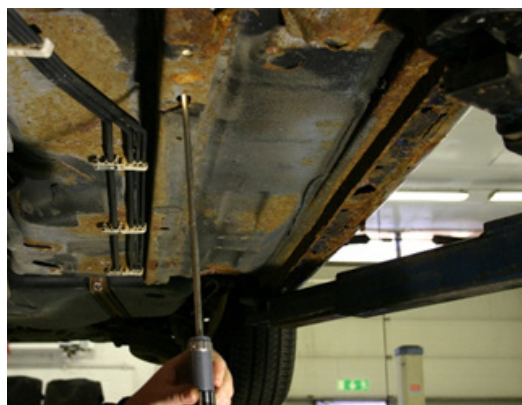
Figure 32 shows how the inside of the left inner side beam looked. The surface has extensive surface rust adjacent to deep-seated rust.

Figure 32. Camera entry point left side beam.

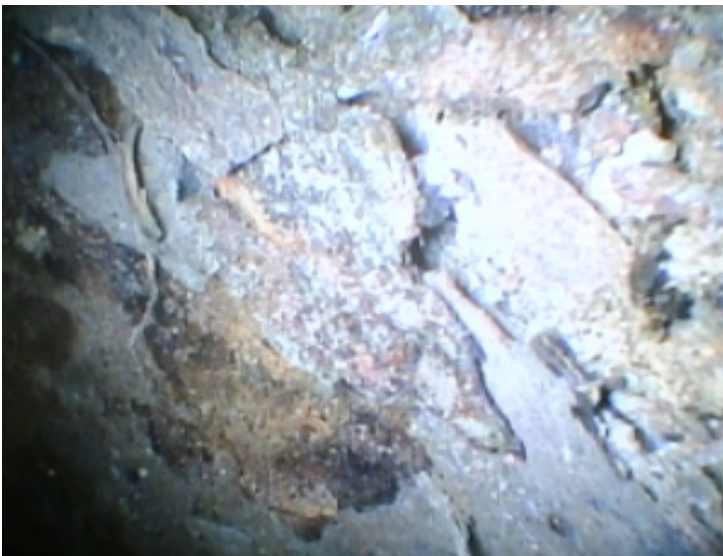
The front-wheel suspension frame belongs to the lower of the crash force transmission paths (Figure 3). The front-wheel suspension frame was severely corroded and was assessed as having large areas of deep-seated rust (Figure 34).

Figure 35. Inside back part of left front-wheel suspension.

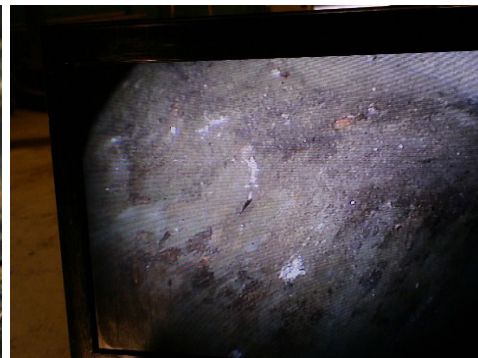
The lower part of the frame beam had sections of deep-seated (Figure 36) while other parts of the frame beam had lighter surface rust. The frame beam was assessed as having a rust level of 3.5 (Table 4).

Figure 37. Frame beam left front inside.

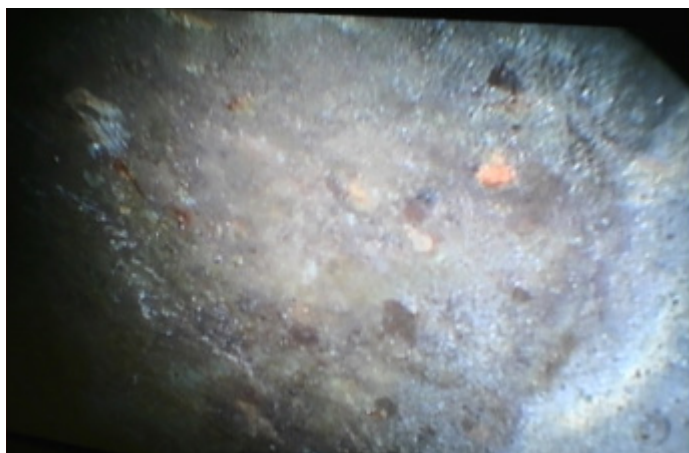
Figure 40 shows widespread surface rust but no deep-seated rust. The camera's position was in the front part of the inner side beam (Figure 40).

Figure 41. Left inner side beam.

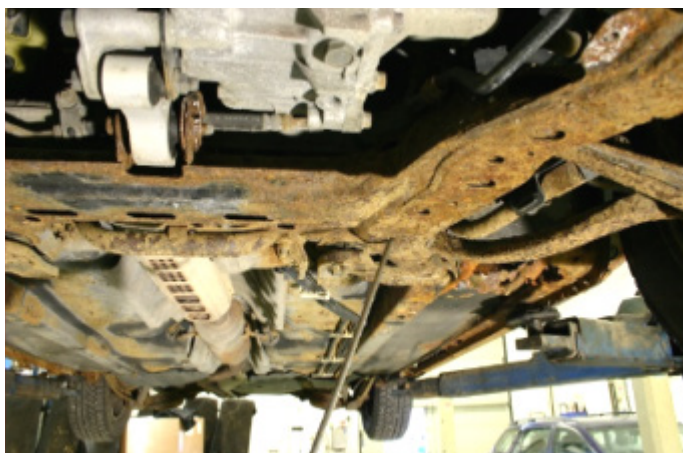
Framvagnsramen (Figur 42) hade något bättre roststatus i sidotestbilen än frontaltestbilen. För sidotestbilen bedömdes framvagnsramens rostangrepp vara en trea (Tabell 4) som innebar omfattande gravrost vilket syns i Figur 43.

Figure 42. Camera entry point back part of left front-wheel suspension.

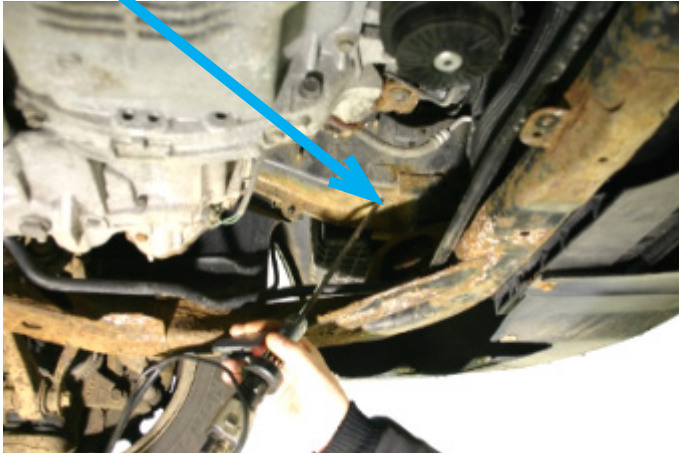
The lower frame beam (Figure 44) had sections adjacent to deep-seated rust (Figure 45) and was given a rust grade of three. The side test car's frame beam was however in better condition than the frontal test car and did not have as extensive a rust spread.

Figure 44. Frame beam left front.

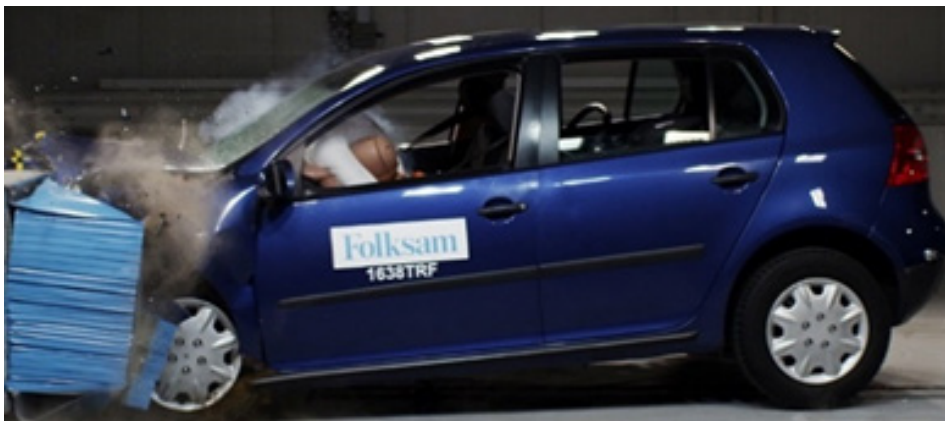
Figure 49. ODB Frontal Impact test.

Table 5 presents the points from the frontal impact test. The score has been calculated directly from the dummy data and shows that the total points for the driver was 14.147. In Appendix 1, four points is given as the driver score for "Knee, Femur & Pelvis". According to the 2004 protocol, point deductions were made according to a so-called "modifier" due to knee contact with the dashboard. Two points were therefore deducted – one for contact with the dashboard and one for concentrated knee load – which is why the final score for the frontal test ended up at 12.147.

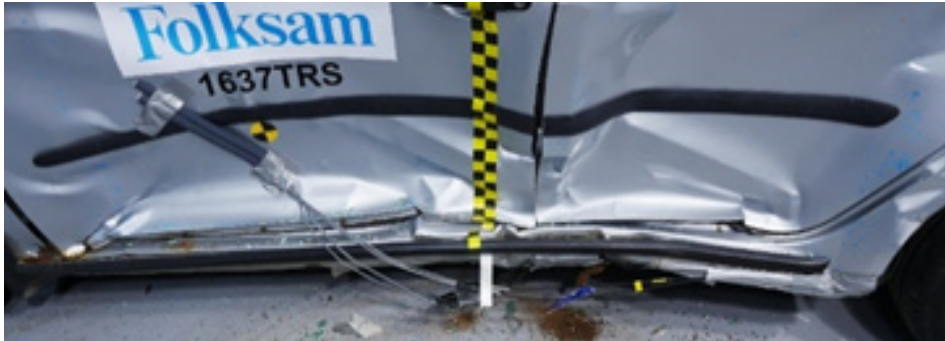
Figure 51 shows the car after the side impact test with a deformable barrier. The side impact test gave 15.585 points (Table 6), which is the same as the original test.

Figure 51. VW Golf (rust) Side impact.

The side impact test showed good crash performance with only a reduction in the score for indentation of the lower part of the chest, which therefore gave the second highest intermediate score. There the chest score was reduced from green to yellow (Table 6). The score for the head was reduced from green with a star to green without a star. The points for the side impact test ended up at 15.808. Appendix 2 shows the test data from the dummy's individual measurements.

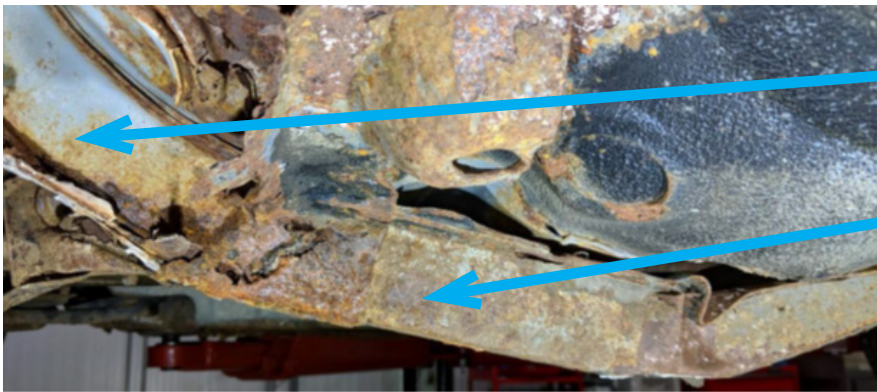
Figure 57 shows the inner side beam on the left side which had areas with widespread surface rust with some areas of localised deep-seated rust (rust level two). The inner side beam was deformed through it being bent in four different places (Figure 57) and pushing the floor upward. The inner side beam also separated from the floor (Figure 58). The transition between frame beam and inner side beam was heavily corroded by rust, which probably weakened that section. In turn, this contributed to a significant deformation of the driver's legroom. The type of deformation indicates that the inner side beam has reached the limit to be able to maintain its deformation properties for increased load. The consequence of the deformation of the inner side beam was that the floor on the driver's side and left passenger side deformed vertically about 15 centimetres with the consequence that the driver's seat mountings were moved. The deformation was greatest on the right-hand side of the driver's seat, which at the same time was violently tilted forward during the collision course. This impacted the forward motion of the dummy and contributed to the head of the crash test dummy bottoming out the airbag and twisting to the left.

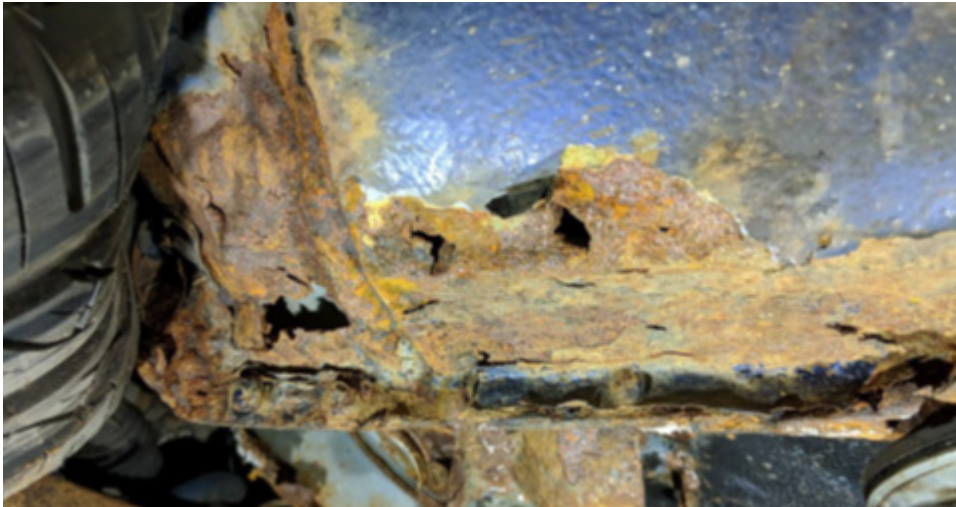
Figure 60 shows the left side beam whose rust level was set at three with extensive corrosion along the entire beam. Behind the front wheel, the side beam was rusted through in several places (Figure 60). The side beam is one of the structures that takes the most load in the frontal impact test, and a weakening here is most likely to result in increased deformation of the compartment. From measurements of crash scenarios, the side beam has been deformed about one decimetre more than the regular test, which corresponds to approximately 35 per cent greater longitudinal deformation of the threshold. The weakening of the side beam also caused a greater load on the inner side beam, which resulted in a greater deformation than in the original test.

Figure 61. Side beam behind left front wheel.
