CHALLENGES AND ACTIVITIES RELATED TO PEDESTRIAN PROTECTION ON ROADS IN POLAND

Kazimierz Jamroz, Tomasz Mackun, Joanna Żukowska

GDAŃSK UNIVERSITY OF TECHNOLOGY

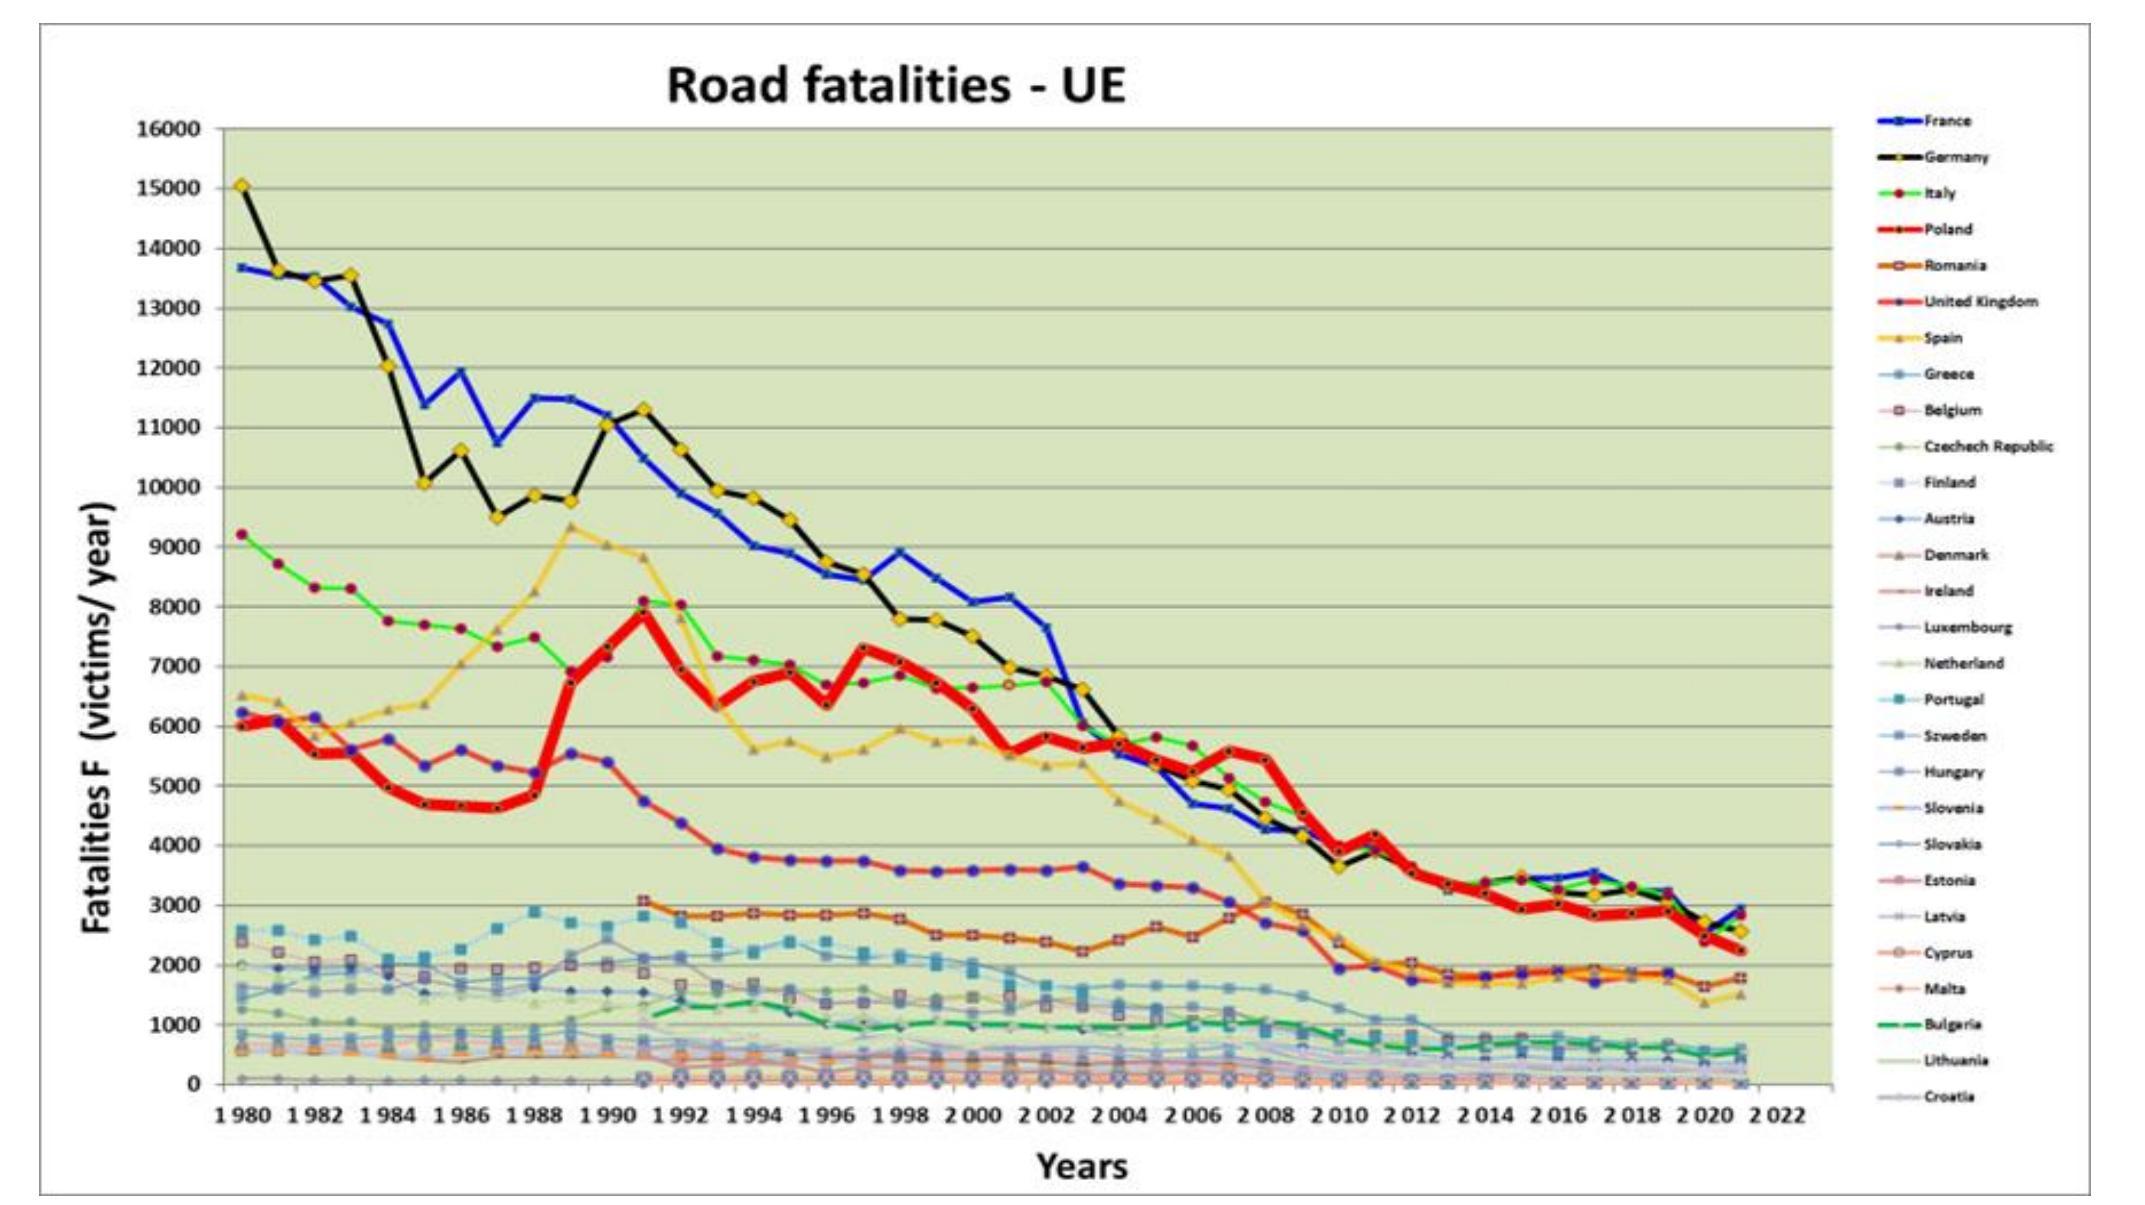
In 1991 - 7901 fatalities in PL, in 2021 - 2245 fatalities: 70 % reduction. In 2004 (PL join EU), during 18 years :

- several times PL was the worst in EU,
- In 2021 was 4th the worst in UE after France, Italy and Germany.
- despite everything number of fatalities decreased by 60% (from 5640 to 2245 fatalities).

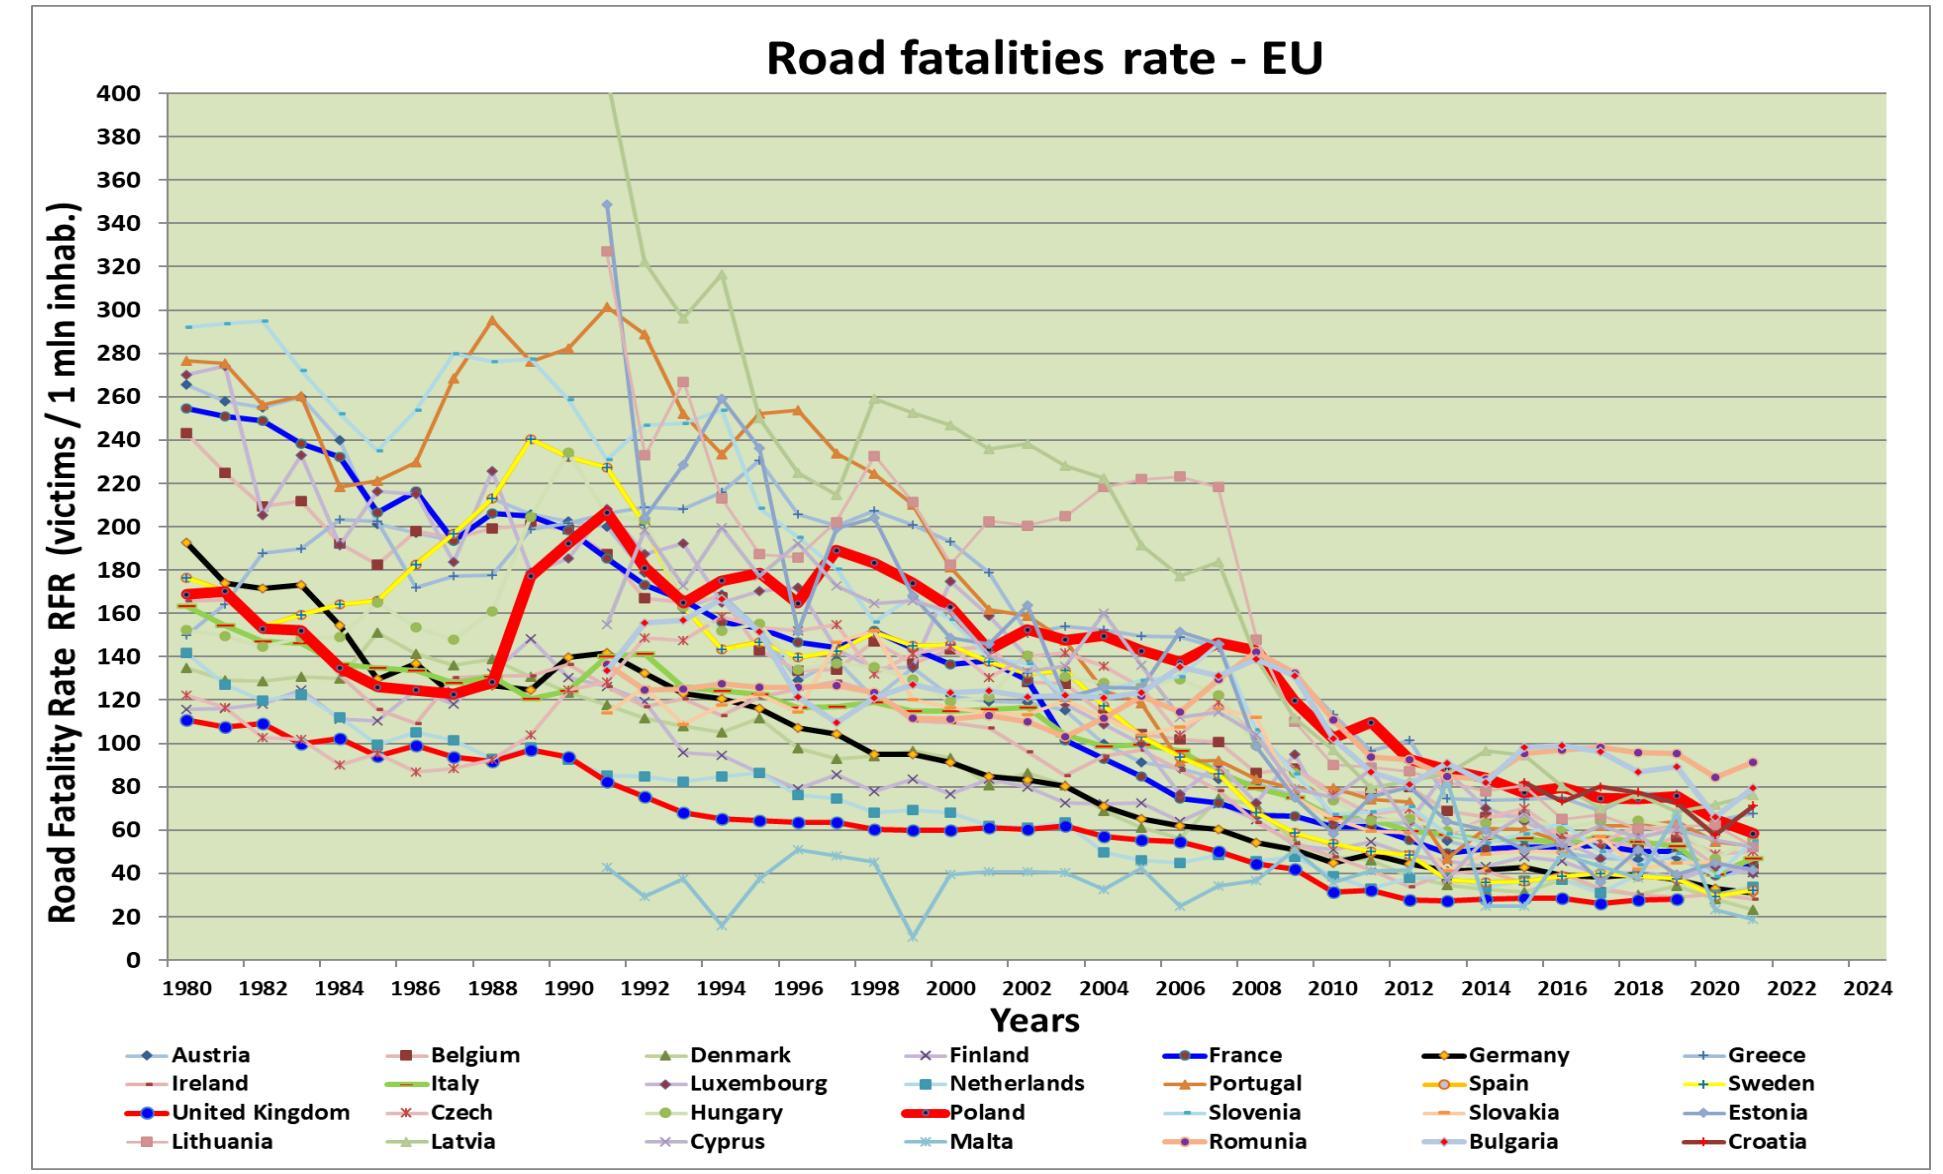
The Road Fatality Rate (RFR) decreased from 145 to 58 deaths / 1 million inhabitants. The RFR in Poland is lower only than Romania, Bulgaria, Greece, Croatia and Latvia. Unfortunately, the risk of being fatal in Poland is:
30% higher than the EU average,
and more than twice as high as in Sweden, Ireland and Denmark.

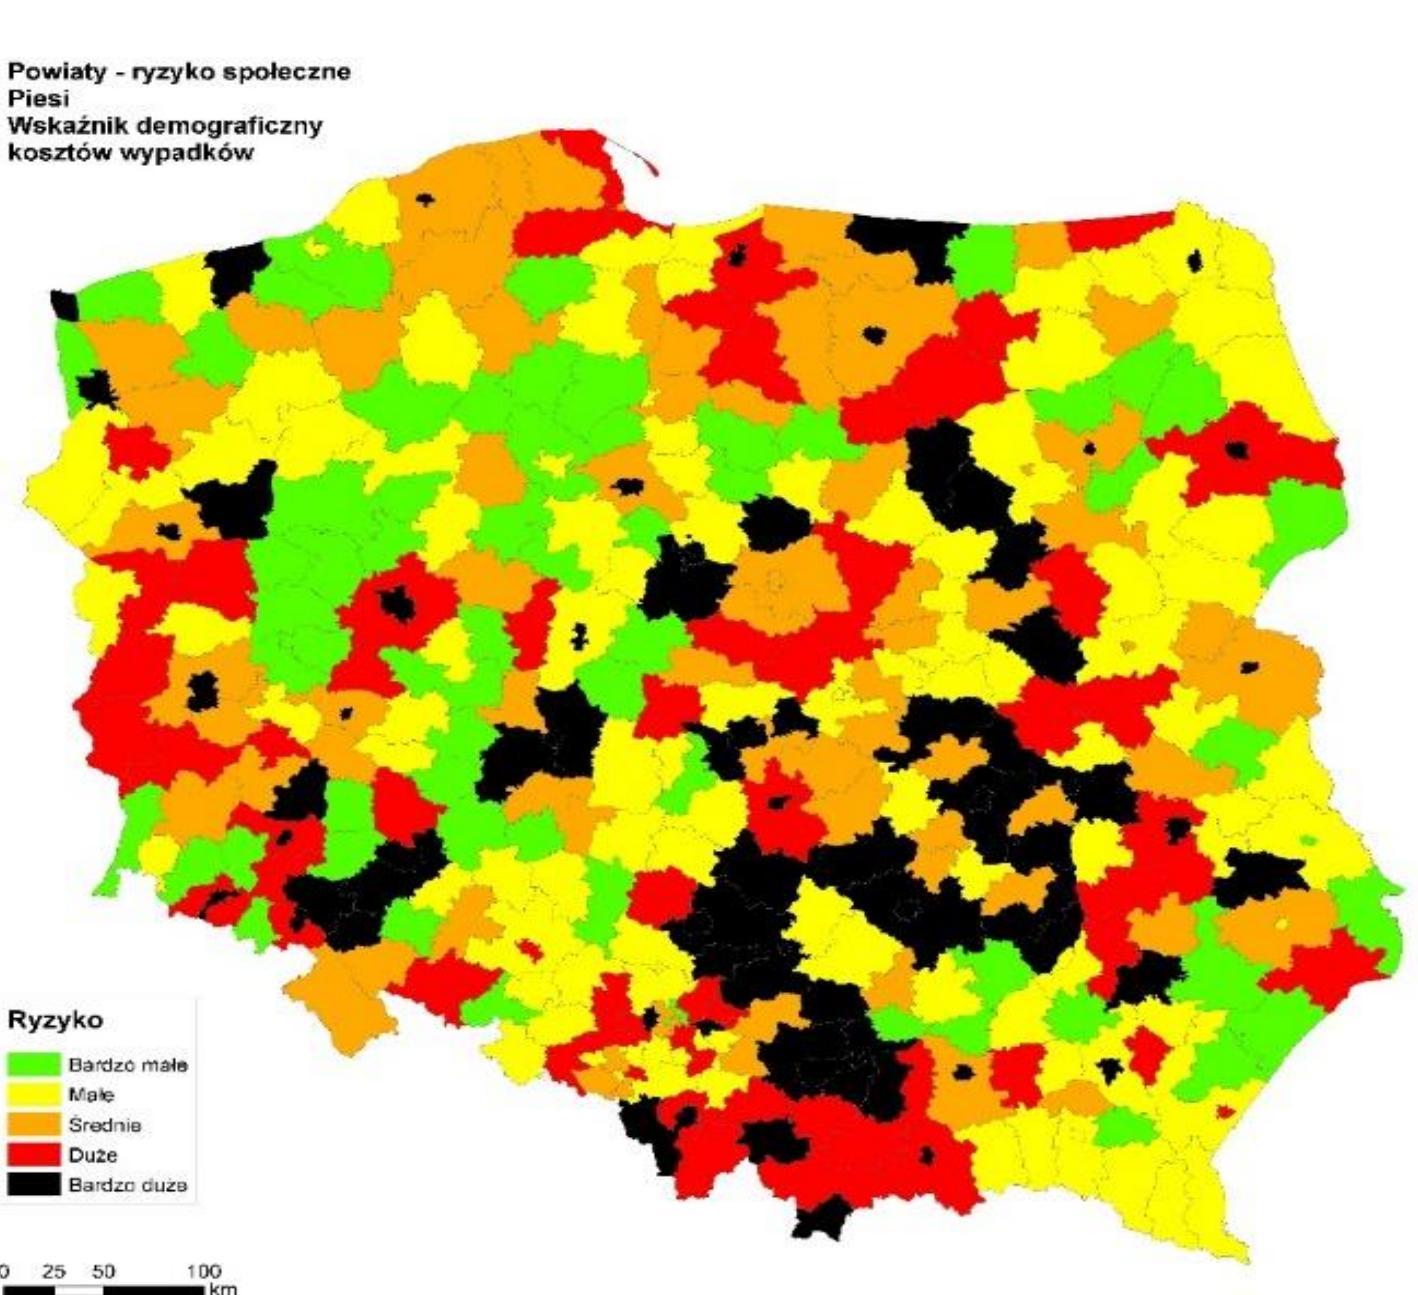
The biggest risk group are seniors and adults

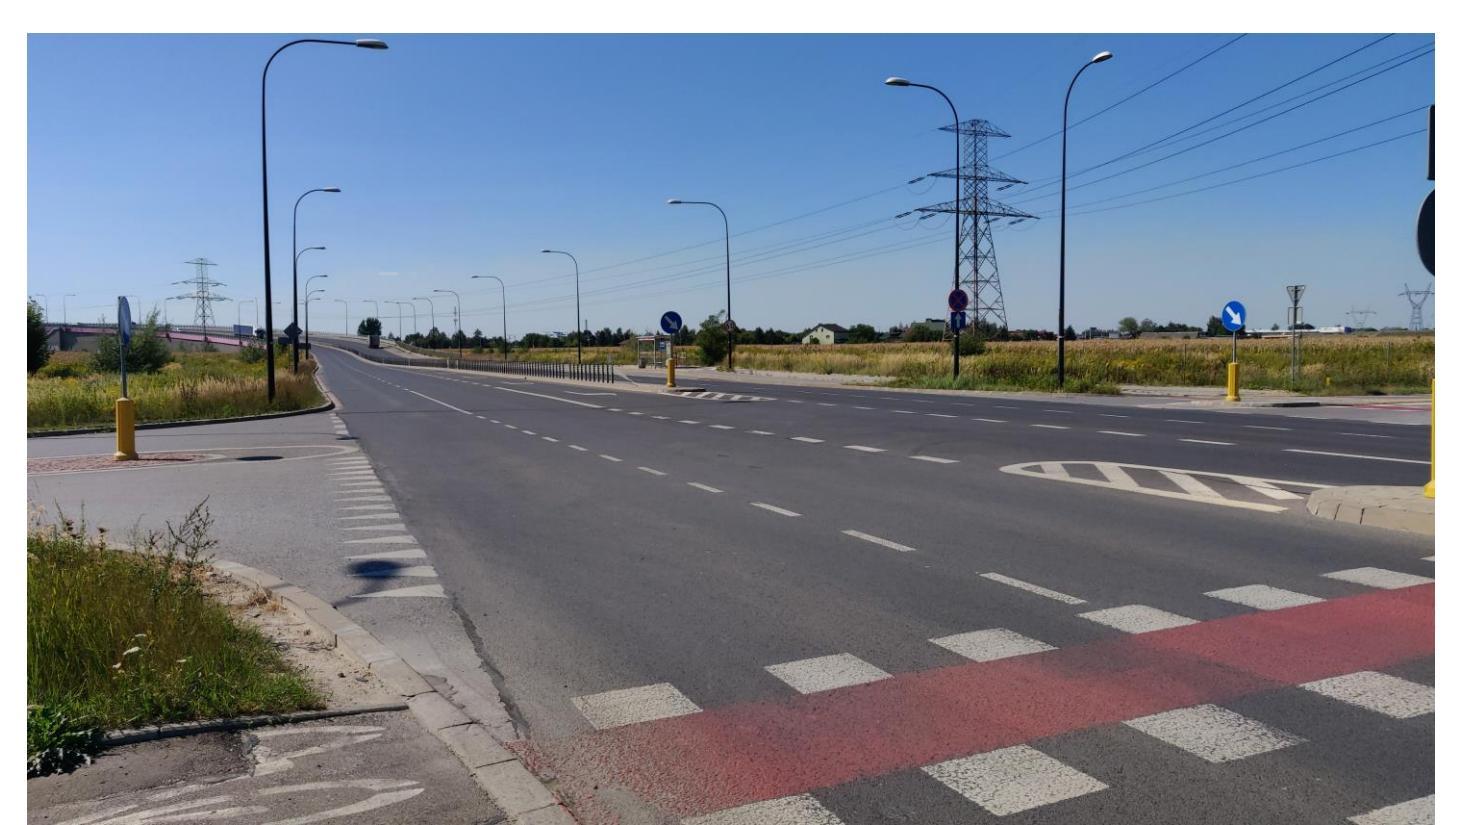
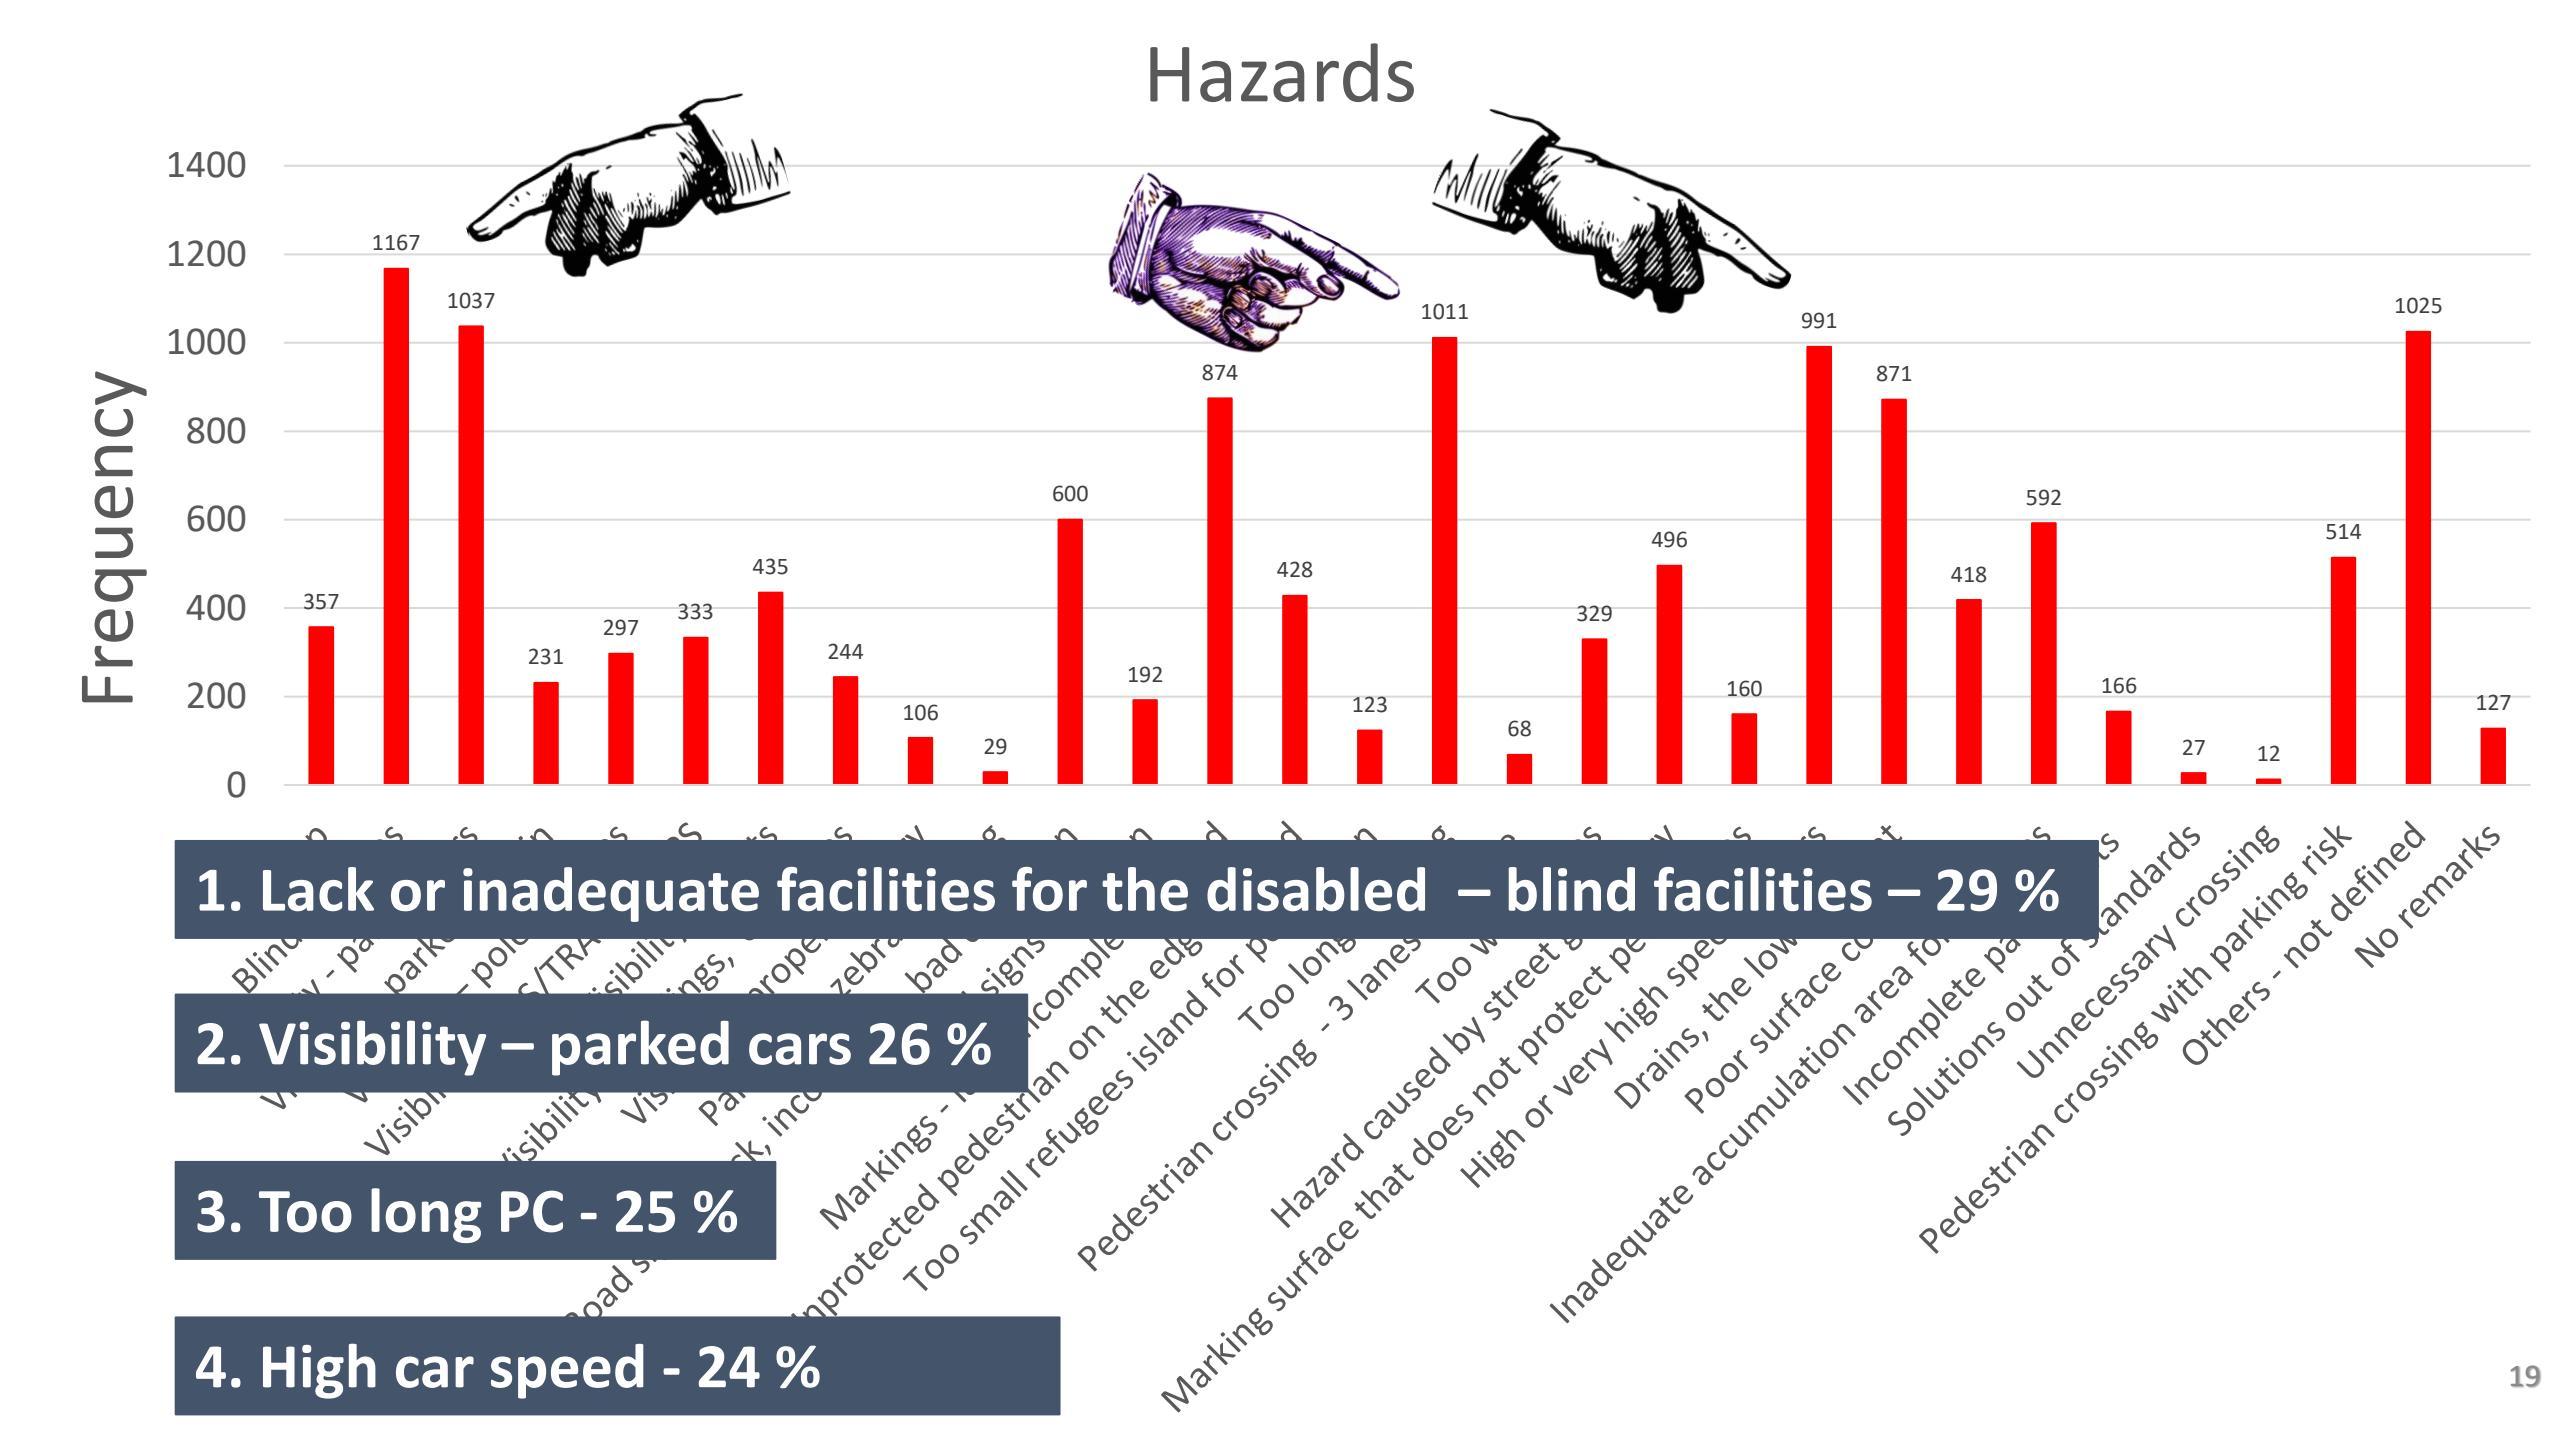
ACCESSIBILITY

Lack or inadequate facilities for the disabled and people with special needs – ramp Lack or inadequate facilities for the disabled – blind facilities

VISIBILITY

Parked cars Poles, fances Bus/Tram stops Plants Buildings, obstacles ROAD SIGNS AND MARKIGS

Road signs - lack, incomplete, bad condition Road signs – hidden Markings - lack, incomplete, faded

GEOMETRY

Unprotected pedestrian on the edge of road Too small refugees island for pedestrian Too long crossing/ 3 lanes or more, too wide lanes Hazard caused by street geometry Markings not protecting pedestrians OTHERS

Gully in crossing area, inadequate road drainage High or very high speed of cars Poor surface condition Incomplete pavements Unnecessary crossing Others - not defined

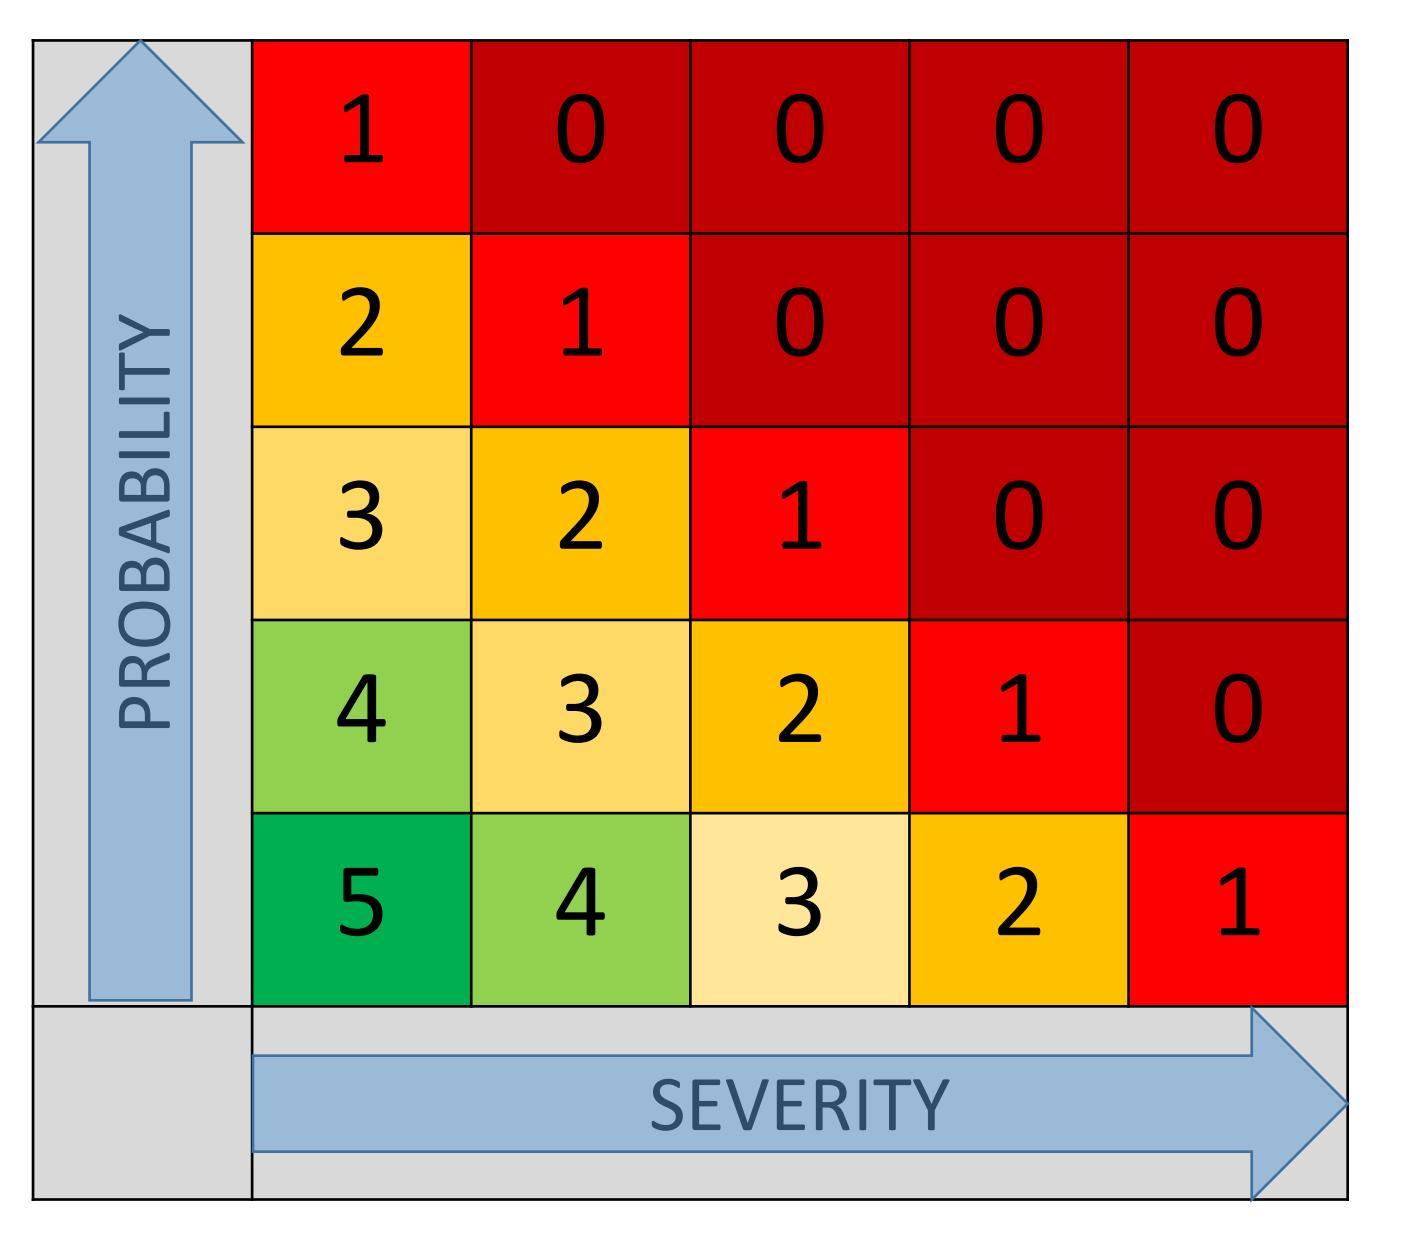
Risk matrix

Volume of cars

Volume of pedestrians

Lack of visibility

length of the pedestrian crossing
